10. Re: Swangard Stadium Turf
 (Item 3, Report 92, December 10, 1973)
 (Item 23, Report 83, November 5, 1973)
 (Item 15, Report 75, October 9, 1973)

Project: Swangard Stadium
Subsurface Drainage Study
Location: Central Park, Burnaby, B. C.
Client: Corporation of District of
Parks and Recreation Department

REPORT AND RECOMMENDATIONS TO CORRECT DRAINAGE
CONDITIONS ON THE SWANGARD STADIUM SPORTS FIELD

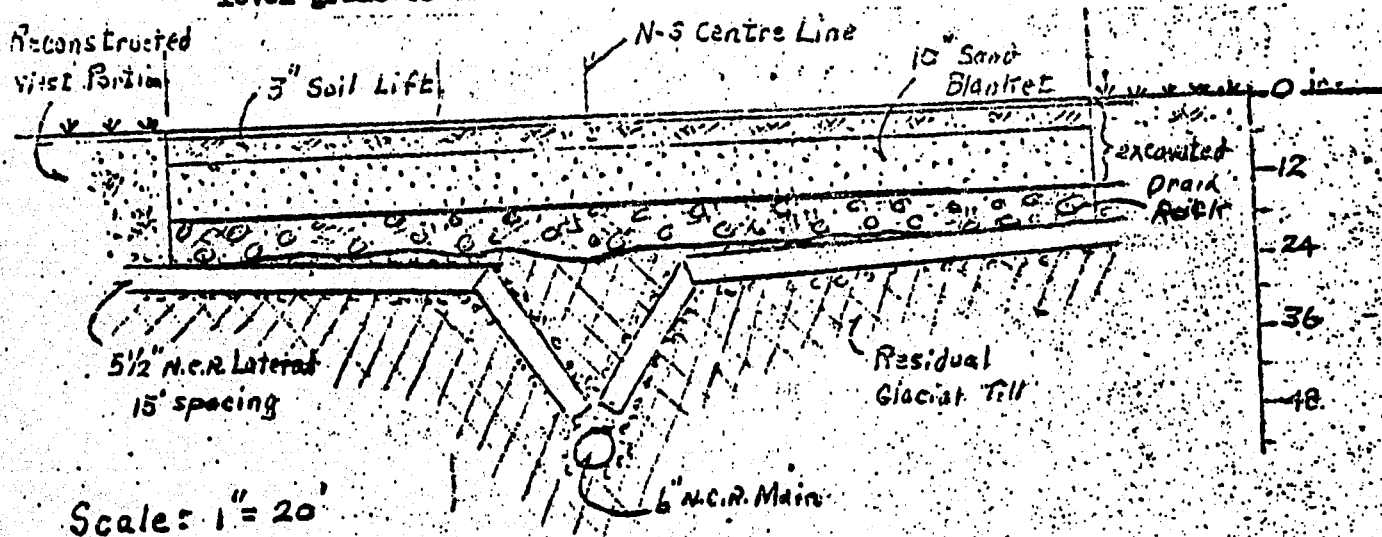
X-Section - Proposed Reconstruction Area

The present combination of the tile drainage system, surface configuration of the field and nature of the soil material above the drains, is inadequate to handle excessive amounts of surface water. This condition is especially apparent in the zone of heavy play use between the goal posts. This zone, comprising a strip 90 to 100 feet wide along the north-south centre line of the field, closely approximates the area of standing water remaining after a heavy downpour or a sustained period of rainfall.

1.) Add 10 inches of coarse sand to the base grade of the excavated zone. This must be a free draining sand conforming to specifications laid down by Ripley et al, uniformly spread and compacted over the entire area.

2.) To the sand base add a 3 inch lift of the residual soil from the stockpile. This material should be well mixed together before it is spread over the sand. A 3 inch thickness is specified on the assumption that the reconstructed area will be finished with a one-inch thickness of sand-grown turf. If the area is to be seeded instead, or if the turf varies from the one-inch thickness, the thickness of the soil lift would be adjusted to give a finished level grade to the field.
