SUBJECT: **3887 PIPER AVENUE, Burnaby, B.C.**
North ½ Lot 4, Block 4, D.L. 42, NW District, Group 1, Plan 9505

PURPOSE: To provide information in response to questions raised at the Council meeting of 1998 August 24 concerning the subject property.

**DRAINAGE & FILL HISTORY
FOR 3887 PIPER AVE
BETWEEN 1967 to 1997**

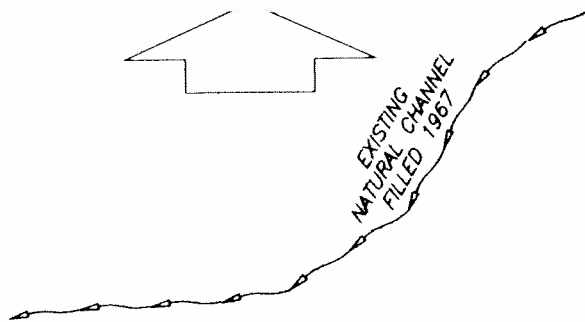
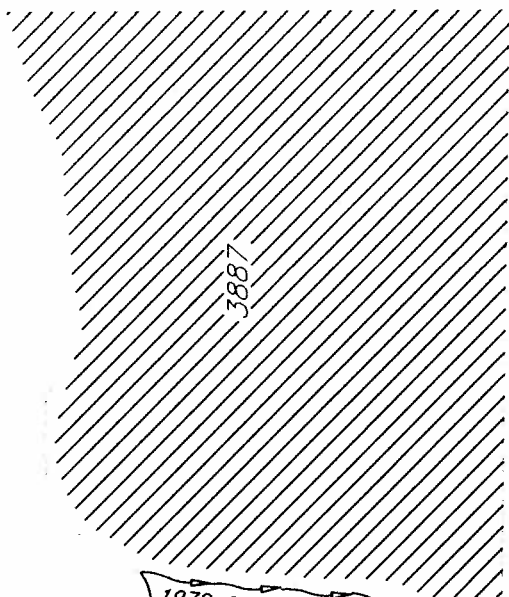
A 475a

As this drawing indicates, an existing natural channel entering from the northeast was filled in 1967 and another existing channel, which flowed out of the property at 3887 to the south was filled in 1972. In 1972 and 1973 the existing natural swale which enters the property on the northwest corner was diverted to a storm sewer at the southeast corner of the property. This was the situation that existed when the current owner purchased the property in early 1997.

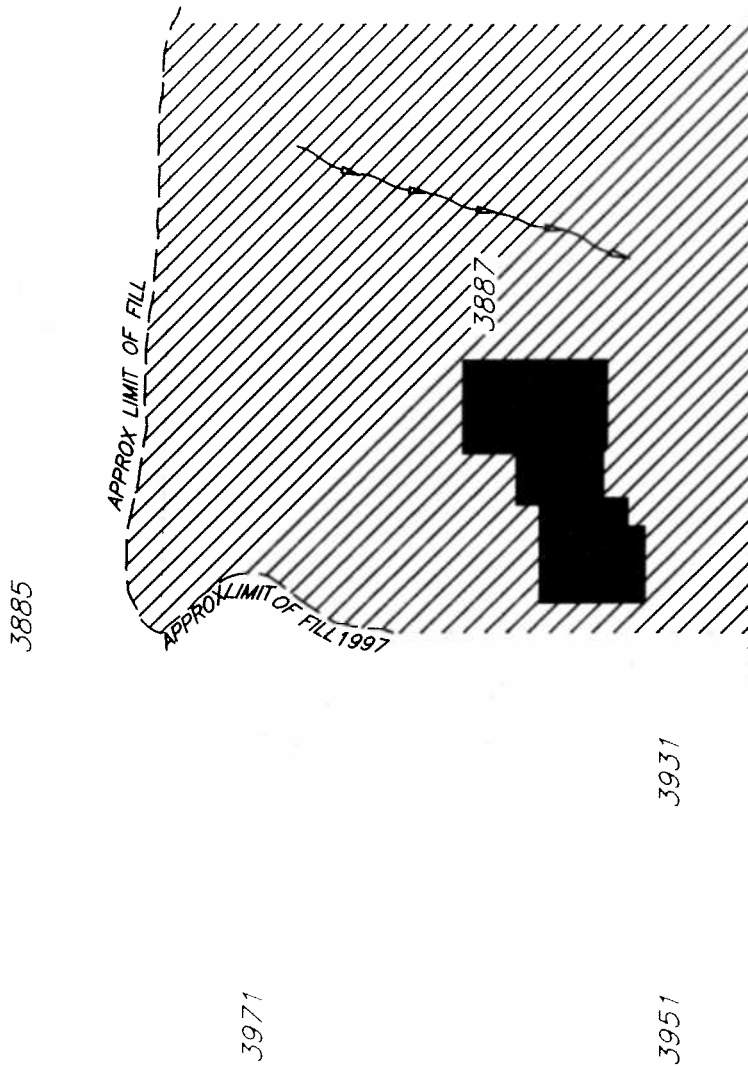
A 475b

During the spring and summer of 1997 the current owner raised the western portion of his property, making it higher than the surrounding properties to the west and south. The natural drainage patterns in the area continued to carry water towards the west and south boundaries of 3887 Piper and the natural swale to the north of the property continued to carry water in from the north, moving it in an easterly direction across the northern portion of the property.

These actions by the property owner interrupted natural water patterns and caused flooding on adjacent properties. Natural drainage from 3885, 3971 and 3931 Piper Avenue no longer had access to the previously existing swale. In addition, the diverted swale on 3887 Piper Avenue was constructed without an outfall. These combined actions led to flooding in and around 3887 Piper during last winter.

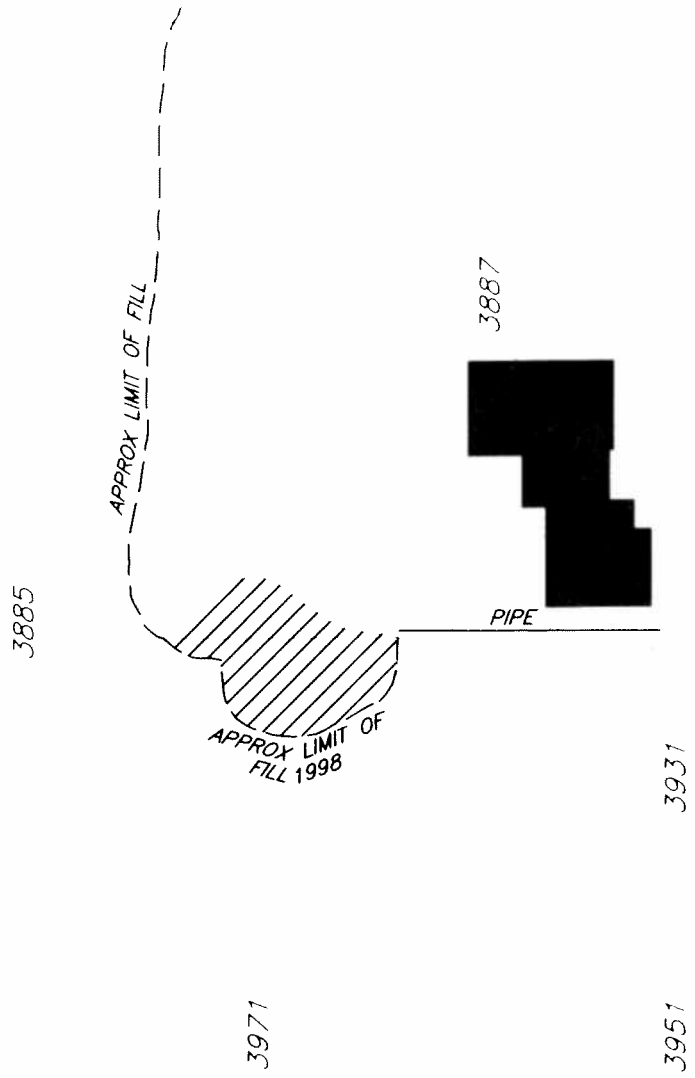
A 475c

In the spring of 1998, the property owner at 3887 Piper placed additional fill on the southwest corner of his property and added a small drainage pipe along the southern edge of the property which helped to eliminate some of the water buildup along the property line between 3971 and 3887 Piper. This does not resolve the problem of the natural drainage which continues to run onto the property from the northwest corner. Since this natural drainage has no avenue of escape from the property it continues to build up along the northern portion of the property and, during wet periods, has the potential to flood field drains around the house on the property.

While construction of the new single family dwelling is virtually complete the watercourse has never been redirected, and as a result the potential for flooding remains a serious threat during rainy periods. In order to correct this situation, the natural drainage across the northern portion of the property must be redirected to the storm sewer at the southeast corner of the property. Until this work is complete, the Building Inspector cannot issue an occupancy certificate for the new single family dwelling which has recently been constructed on the property.
