TO: CITY MANAGER 1999 APRIL 20

FROM: DIRECTOR PLANNING AND BUILDING

SUBJECT: CORRESPONDENCE FROM RESIDENTS OF KALYK AVENUE
REGARDING THE HONG KONG BANK SITE EXCAVATIONS
X-REF. REZONING REFERENCE # 64/97

PURPOSE: To respond to issues raised in the correspondence regarding excavations at the Hong Kong Bank site on Gilmore Way.

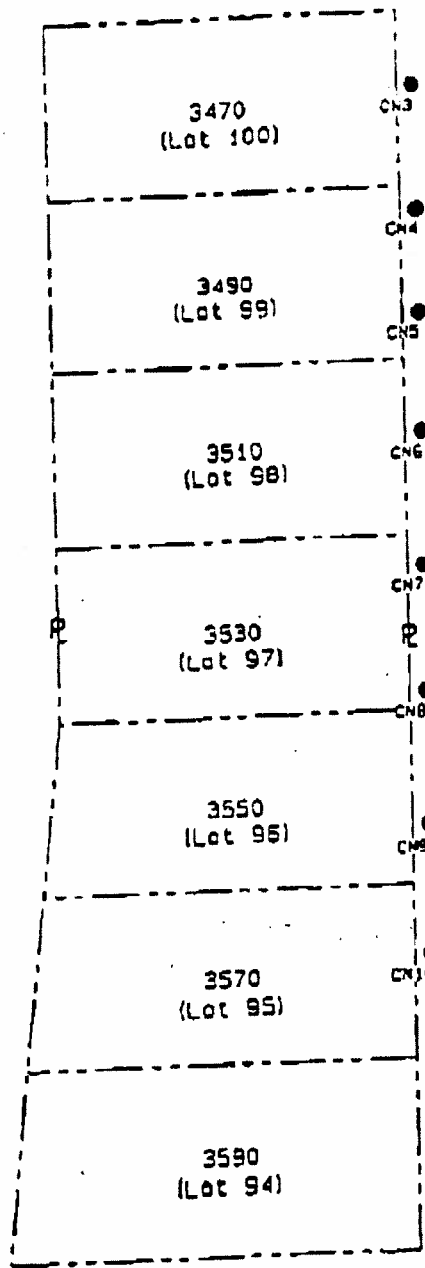
SURVEY LOCATION PLAN FOR LANE (WEST OF SITE)
3555 GILMORE WAY, EURNABY

The survey monitoring included two lines of survey points along the lane, one on the east side of the lane and one on the west side (about .5 ft. from the rear property line of the Kalyk Avenue properties). The survey records indicate that, since the time that the survey points were installed at the end of October, horizontal movements on the west side of the lane were typically 14 mm, except at the one location where the significant asphalt cracking was observed and movements were in the order of 45 mm. The survey records confirm that movements have been minimal over the past four months, and that

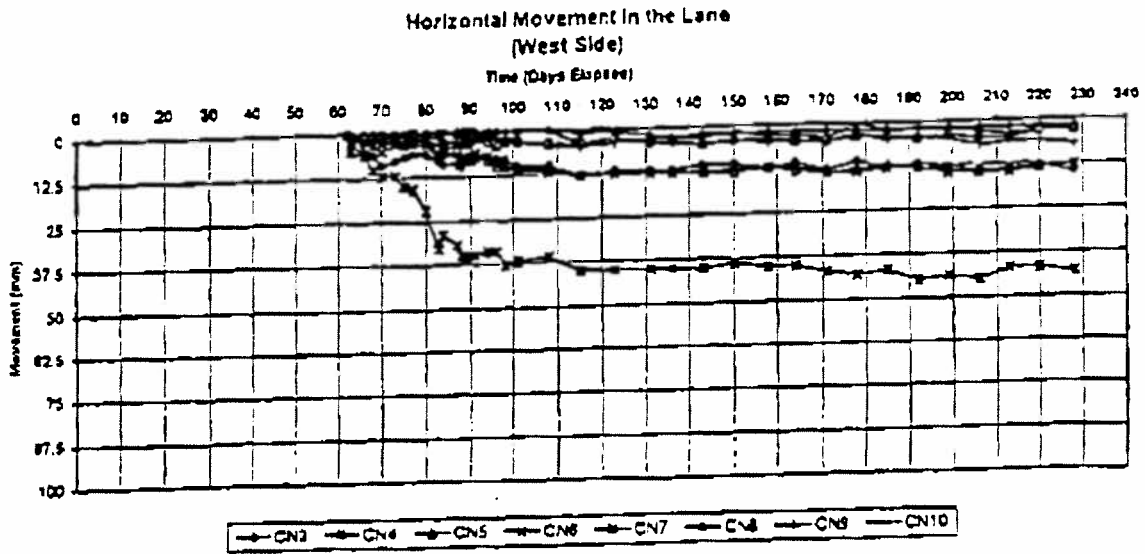
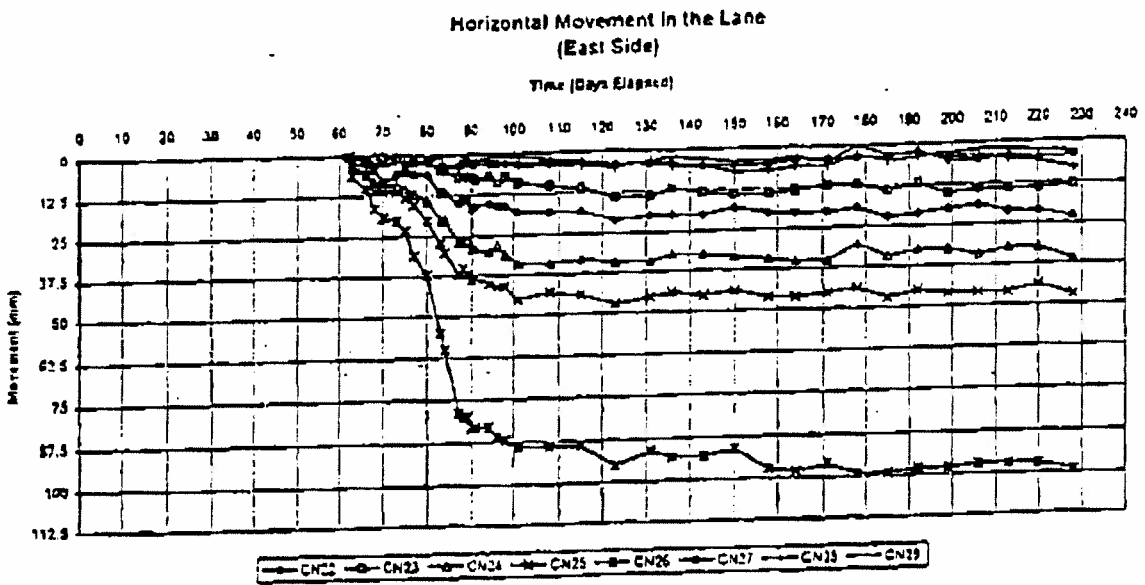
HORIZONTAL MOVEMENT IN THE LANE (WEST OF SITE)
3555 GILMORE WAY, BURNABY

movements have essentially stopped over the past six weeks since the excavation has been substantially completed. A plot of the lane survey data is attached. The attached Dwg. No. 501-9502 shows the location of the survey points relative to the Kalyk Avenue properties, and the attached Dwg. No. 502-9502 presents a plot of the survey results.
