CITY OF BURNABY

**B. FRASER PARK DRIVE AT BYRNE ROAD**

**SUBJECT:** FRASER PARK DRIVE AT BYRNE ROAD

**DATE:** 1998 02 19

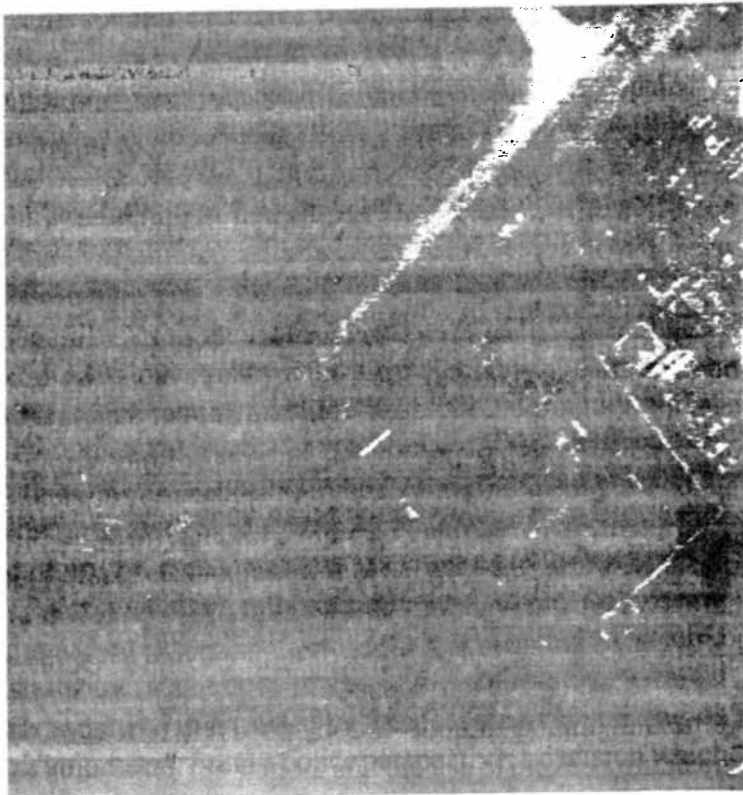
As a result of a complaint received over the phone, staff conducted a review of the stop control on Fraser Park Drive at Byrne Road. The caller was perplexed as to the purpose of the stop sign where no right of way control is required and cited a high incidence of non-compliance.

Byrne Road and Fraser Park Drive form a two leg 90 degree corner. Vehicles travelling south on Byrne have free movement, while vehicles travelling west on Fraser Park must stop. There are no conflicting right of way movements or intersecting roads / driveways at this location, and there are no records of accidents over the last five years. Sight lines are also excellent on both approaches and traffic volumes are relatively low. The picture on the right shows the basic layout of the corner.

The Uniform Traffic Control Devices for Canada (UTCD) manual (section A2.11.2) clearly states that the use of stop signs is limited to right of way control. Since there are no conflicting flows to manage, a stop sign here is unnecessary, in its place curve warning signs are recommended.

Installation should consist of a curve warning sign (checkerboard WA-8R) with centerline and reflective pavement markers. This is the typical treatment for corners like this and would bring it more in line with guidelines set out in the UTCD manual and general road marking practises.

The stop sign for westbound Fraser Park Drive to northbound Byrne Road should be removed, and replaced with appropriate curve warning signs and a centerline with reflective pavement markers. This would be the most appropriate treatment for this type of corner according to the UTCD manual, will reduce delay to drivers, and eliminate the problem of drivers ignoring the stop sign.
