TRAFFIC SAFETY COMMITTEE

SUBJECT: INTERSECTION OF HASTINGS AND INLET

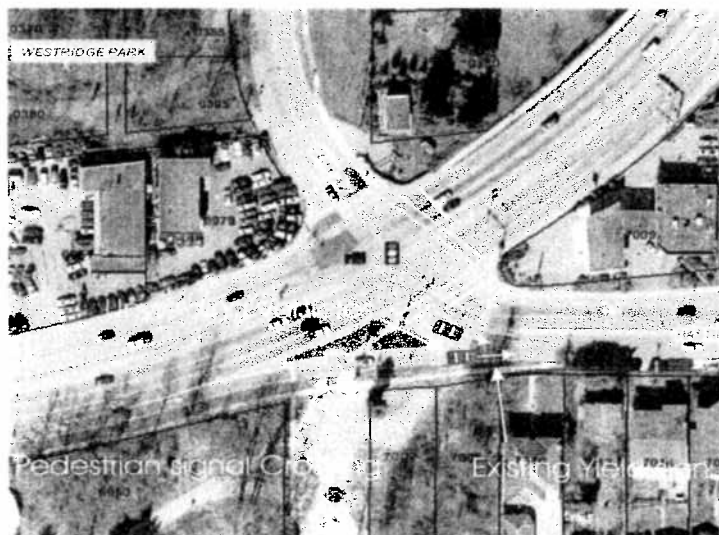
Exhibit 1

Ms. Cairns states that at this intersection, vehicles using the right turn sweep from Hastings onto Hastings routinely violate the yield sign at excessive speed causing her near collisions on several occasions. She suggests RCMP enforcement and replacing the yield with a stop sign.

This intersection comprises two Arterial Primary (Hastings/Inlet) and a Local Collector (Cliff). The intersection possesses two signal systems, one for the major intersection and a separate pedestrian signal on the Hastings to Hastings sweep. The sweep has a large radius curve that is conducive to maintaining the travel speed when exiting. In addition, sight lines are good further raising the confidence drivers approaching the yield.

Replacing the yield with a stop is not warranted because the sightlines provide adequate warning of approaching vehicles and merge symmetry is present. Compliance for a stop sign here would likely be low and may even cause a rise in rear end collisions.

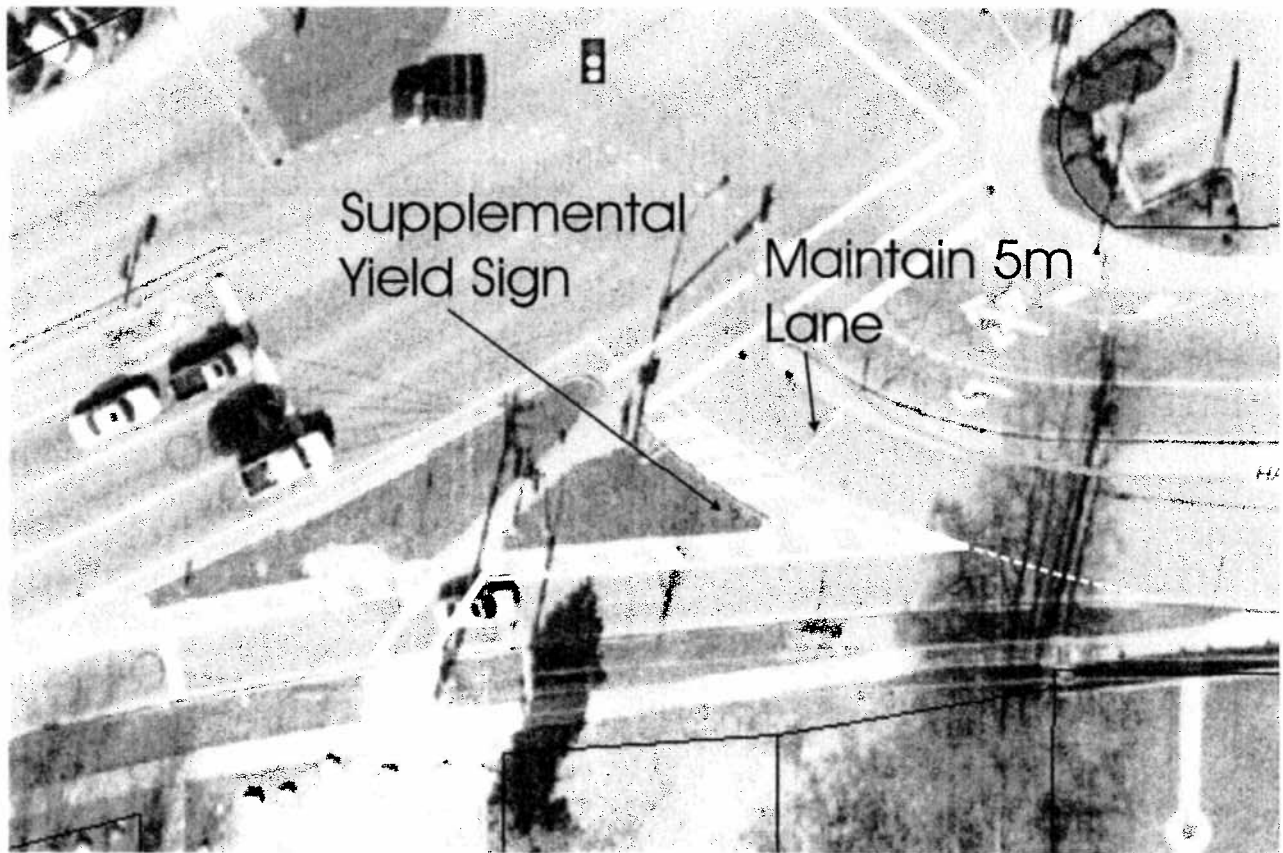
In order to mitigate right of way conflicts, slow down traffic and better define the yield requirements, the following adjustments are to be completed (see exhibit 2)

1. Add gore markings to the painted edge line on the sweep and repaint the crosswalk. This will give a perceived narrowing effect and reinforce the presence of the crosswalk in an attempt to slow traffic.
2. Add gore markings and reduce the lane width from the Cliff/Inlet access to Hastings creating more separation between the through and merge lanes.
3. Add wide broken line across merge lane onto Hastings to better define right of way.
4. Add a supplemental yield sign on the left hand side of the sweep at Hastings to reinforce right of way.
