**SUBJECT: INTERSECTION OPERATIONS – BERESFORD STREET AT  
WILLINGDON AVENUE**

**SUBJECT:** INTERSECTION OPERATIONS - BERESFORD ST AT WILLINGDON AVE

**PURPOSE:** To review safety and operational concerns at the intersection of Beresford St and Willingdon Ave.

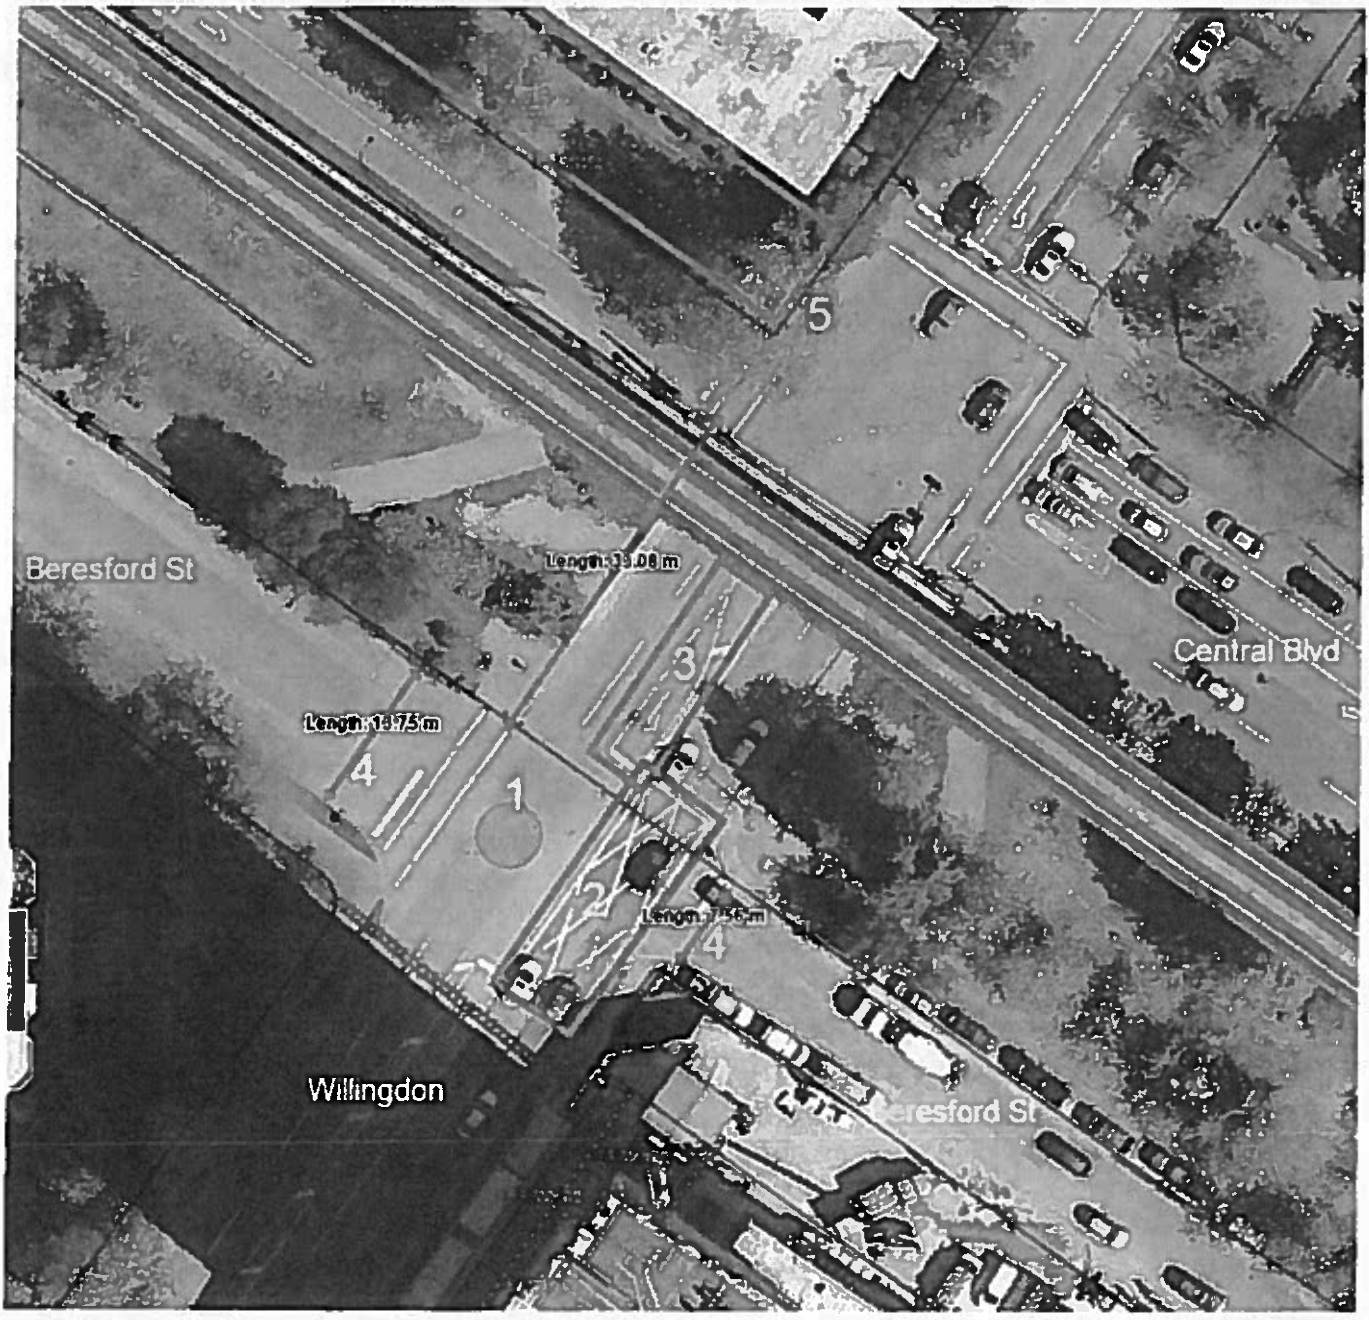
Figure 2: Existing Issues at the Beresford St/Willingdon Ave Intersection

The key safety and operational issues at the Beresford /Willingdon intersection are illustrated on Figure 2 and include:

1. The stop-controlled approaches experience long delays and this causes driver frustration and encourages them to attempt unsafe turning and crossing manoeuvres. With growing traffic volumes, a higher number of crashes could be expected in the future;

2. This intersection is only 33 metres from a major signalized intersection at Central Blvd/Willingdon Ave. Because of this the queue of northbound traffic on Willingdon Ave stopped for red lights often blocks Beresford St. Despite pavement markings and traffic signs, this is a recurring issue that impedes drivers on Beresford from turning onto or going across Willingdon;

3. For southbound left turn from Willingdon onto Beresford a very short left turn lane is provided with storage for only one vehicle (7.0 m long). Therefore any additional vehicle waiting to make the same left turn from Willingdon onto Beresford would block a travel lane on Willingdon Ave. This increases the potential for rear end and side swipe crashes, and also reduces the capacity of Willingdon Ave and the signalized intersection;

4. The east and west legs of Beresford St at Willingdon Ave have an inconsistent cross-section geometry and do not align properly. Due to limited road right-of-way, Beresford St does not have standard urban design features and parking encroaches onto the adjacent BC Parkway corridor;

- 5. Central Blvd/Willingdon Ave is a key four-leg signalized intersection with a major right-of-way constraint on the northwest corner of this intersection. This affects the geometry and laning at this intersection and impedes signal operations. Separate signal phases for eastbound and westbound traffic have to be used due to the alignment problem which worsens operational conditions at this location.
