ITEM  
MANAGER'S REPORT NO. 14  
COUNCIL MEETING 13  
89/02/13

RE: LETTER FROM STRATACO/BRADSON WHICH APPEARED ON THE AGENDA FOR THE  
JANUARY 30TH MEETING OF COUNCIL (3 E)  
DRAINAGE PROBLEM AT CASCADE VILLAGE, 3960 CANADA WAY

SUBJECT: DRAINAGE ENQUIRY - CASCADE VILLAGE  
3960 CANADA WAY

PURPOSE: TO PROVIDE COUNCIL WITH INFORMATION REGARDING  
A DRAINAGE PROBLEM AT 3960 CANADA WAY

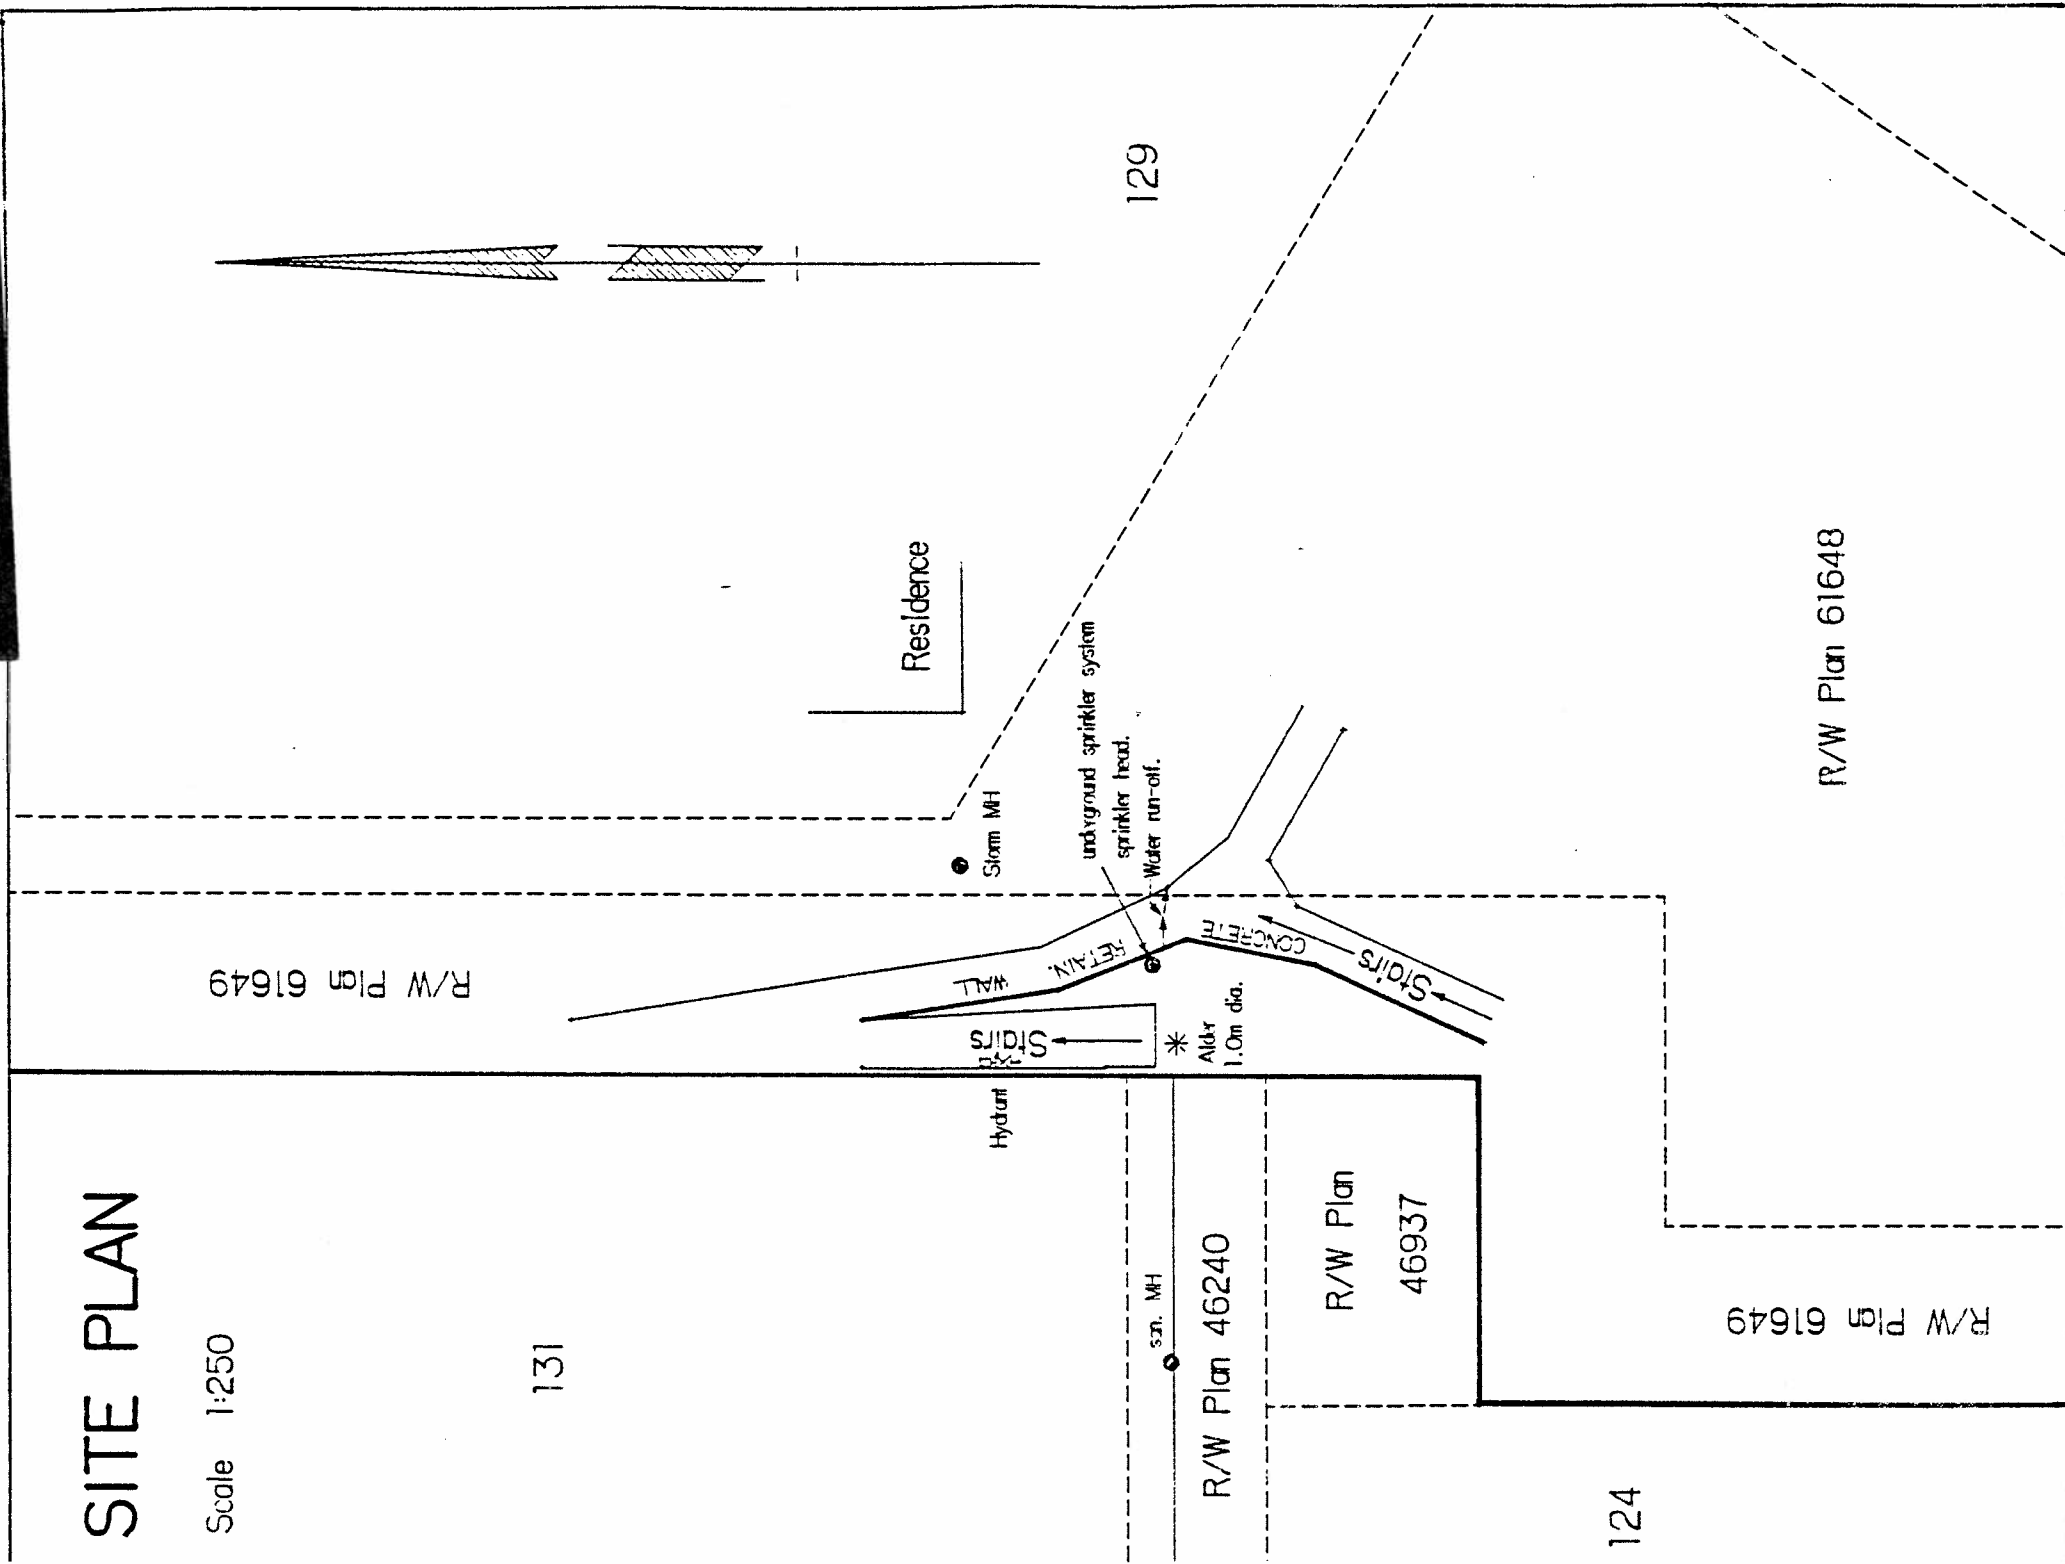
# SKETCH No. 2

The drainage problem is the result of seepage which emanates from under a retaining wall, crosses a walkway and flows onto a grassed landscaped area. The Municipality, however, does not own property in this vicinity. The retaining wall and walkway are located on a Statutory Right-of-Way over the common property of Strata N.W. 2153 (Cascade Village). The right-of-way agreement between the Municipality and the property owner requires that the owner maintain the sidewalk and right-of-way in good and reasonable repair. The agreement places no maintenance obligations on the Municipality. Sketch No. 1 (attached) shows the right-of-way in relation to surrounding streets and Sketch No. 2 (attached) provides a greater detail of the physical features in this area.

Staff have checked all Municipal utilities in the area including the adjacent hydrant. No leakages were evident and all facilities appear to be functioning in good order. The drainage seepage seems to be natural subsurface drainage flowing from the higher elevations to the west. Correction of the problem could be achieved by additional tile drain installation, the responsibility for which would rest with the property owner.

## SITE PLAN

Water run-off.
