THE CORPORATION OF THE DISTRICT OF BURNABY

TRAFFIC SAFETY COMMITTEE

REPORT OF THE TRAFFIC SAFETY COMMITTEE

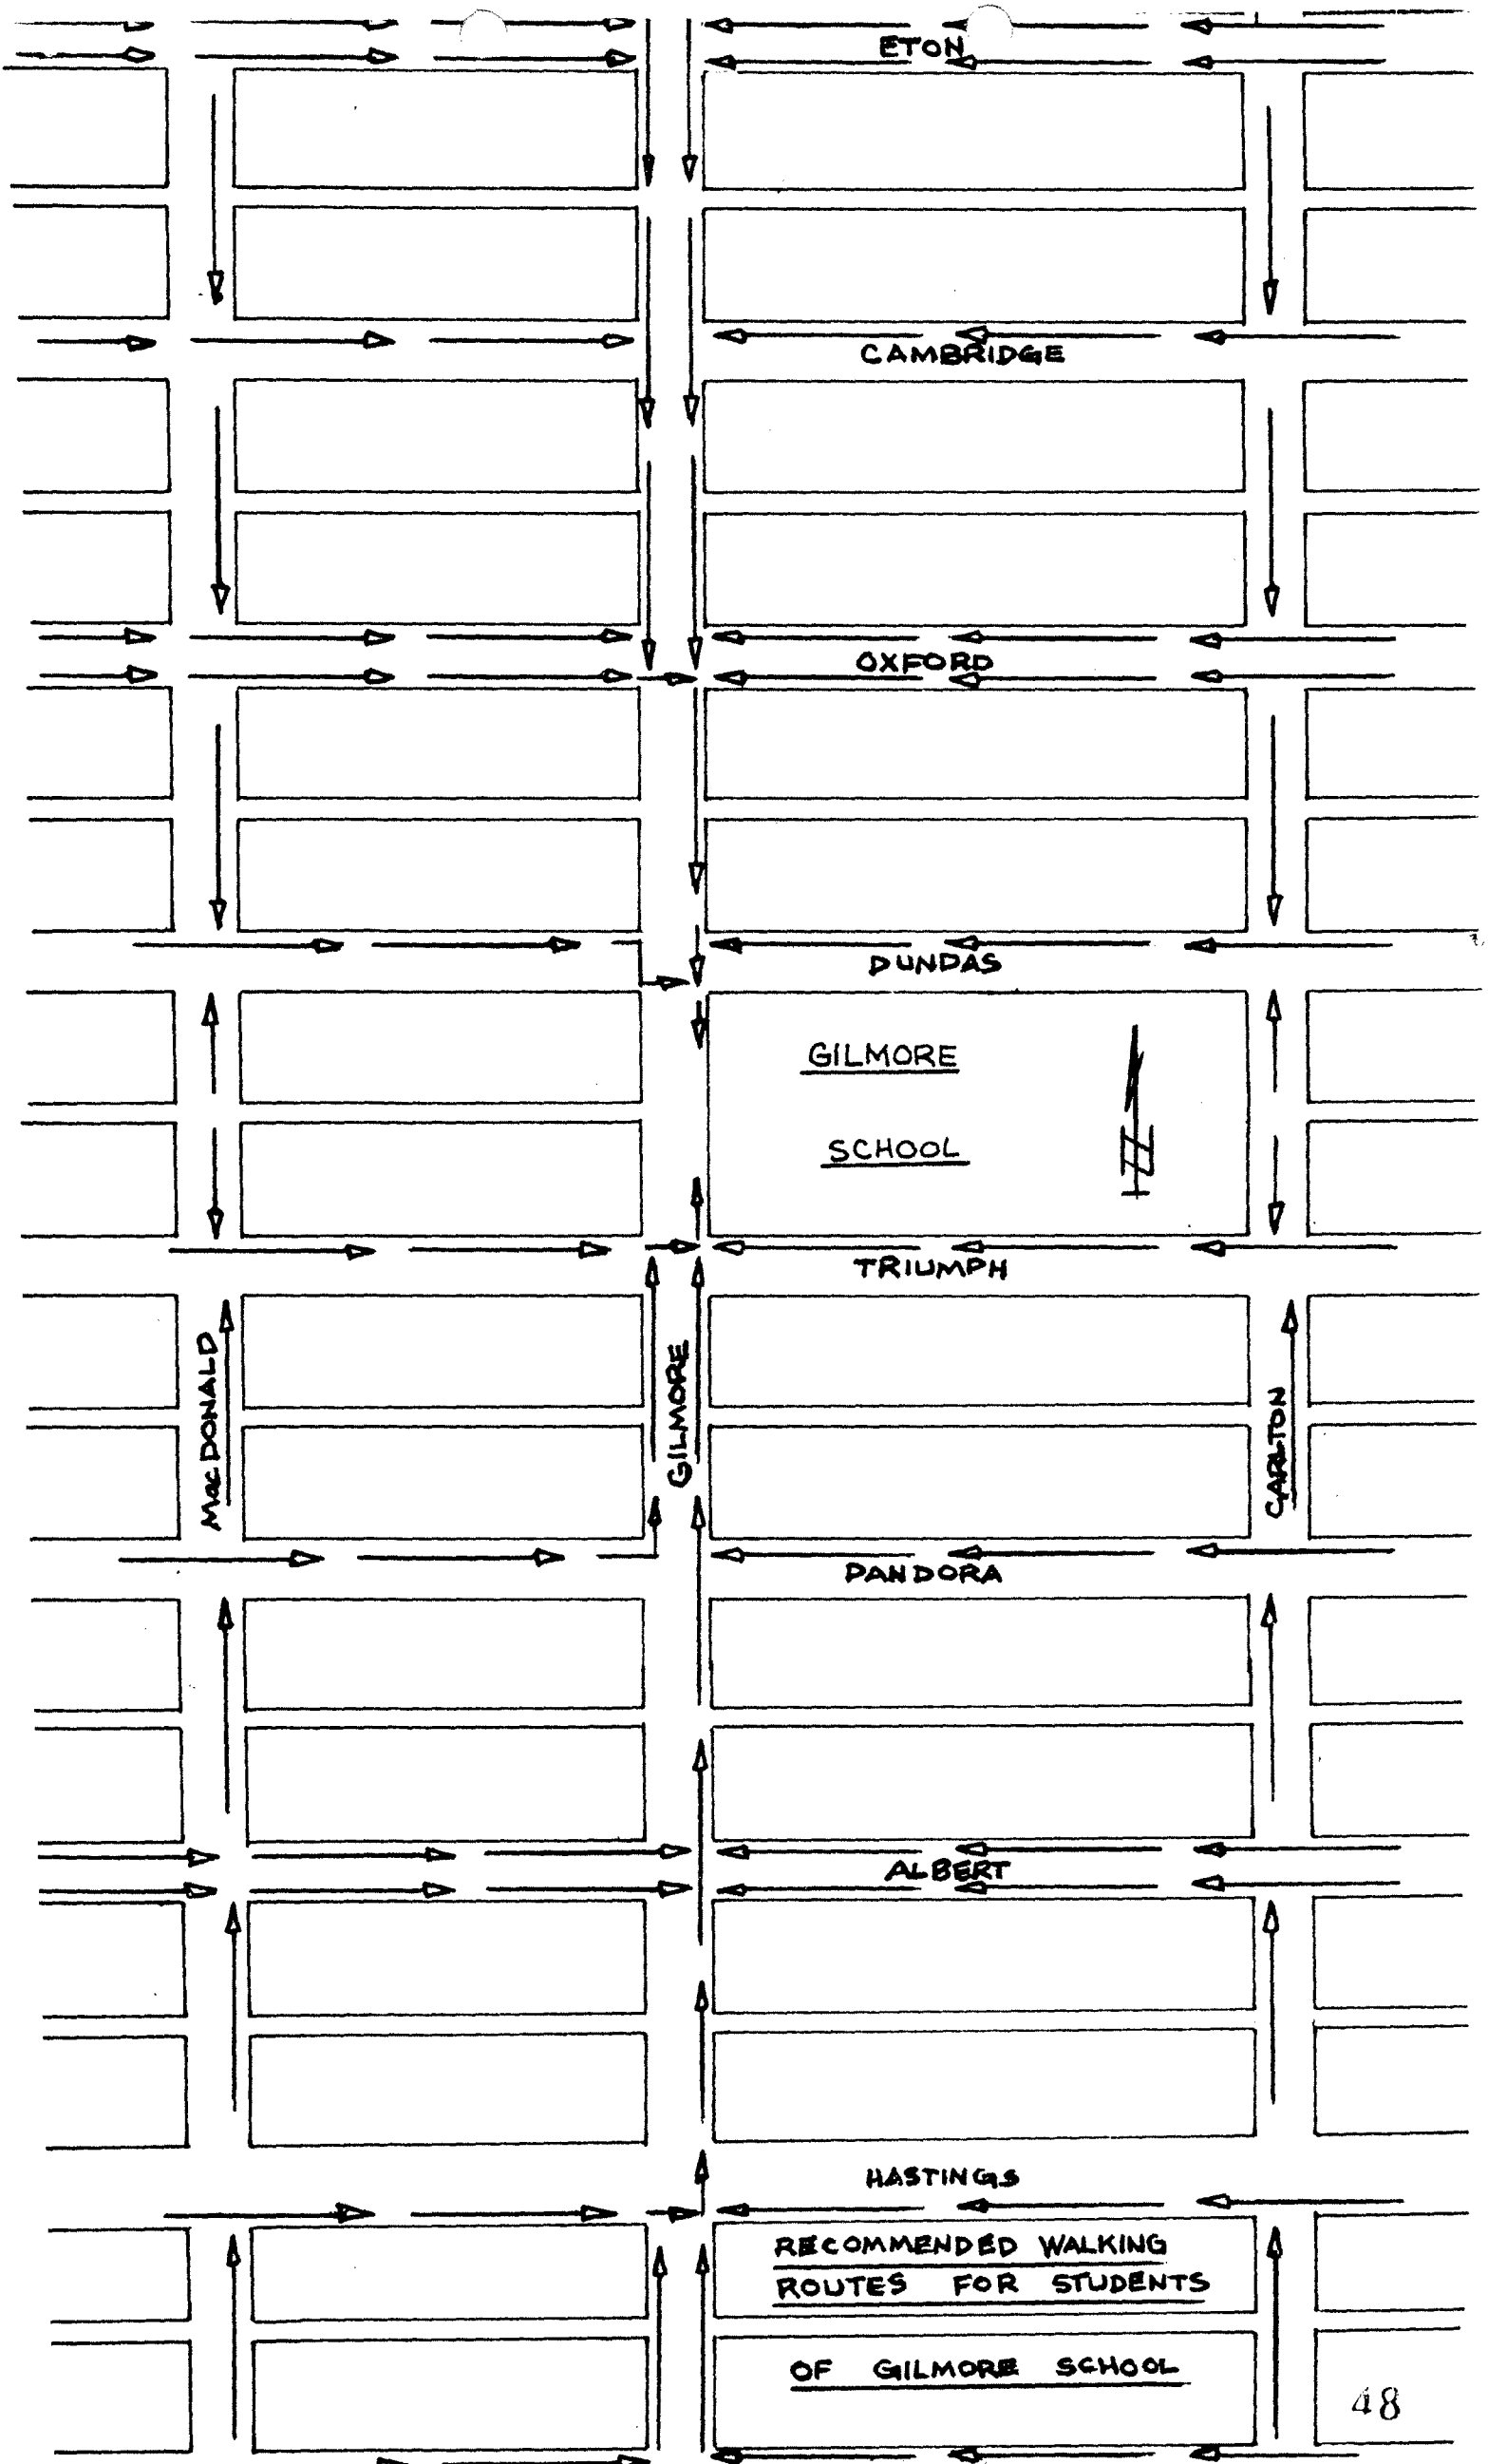
GILMORE  
SCHOOL

RECOMMENDED WALKING  
ROUTES FOR STUDENTS

The most recent request is for marked and supervised crosswalks on Gilmore Avenue in front of the school and at the intersection of Gilmore Avenue and Oxford Street. As noted in the previous report there are no warrants for marked crosswalks on Gilmore Avenue, a condition that is still valid. The suggestion of marked and supervised crosswalks at the intersection of Gilmore and Oxford would not meet the conditions of our adopted warrant for this type of treatment as the intersection is controlled on all legs by stop signs. All students attending Gilmore School who live north of Oxford Street should cross at this intersection because of its stop sign vehicle control. Attached as Appendix 'A' to this report is a sketch suggesting routes which the school students may use.
