THE CORPORATION OF THE DISTRICT OF BURNABY

TRAFFIC SAFETY COMMITTEE

REPORT OF THE TRAFFIC SAFETY COMMITTEE

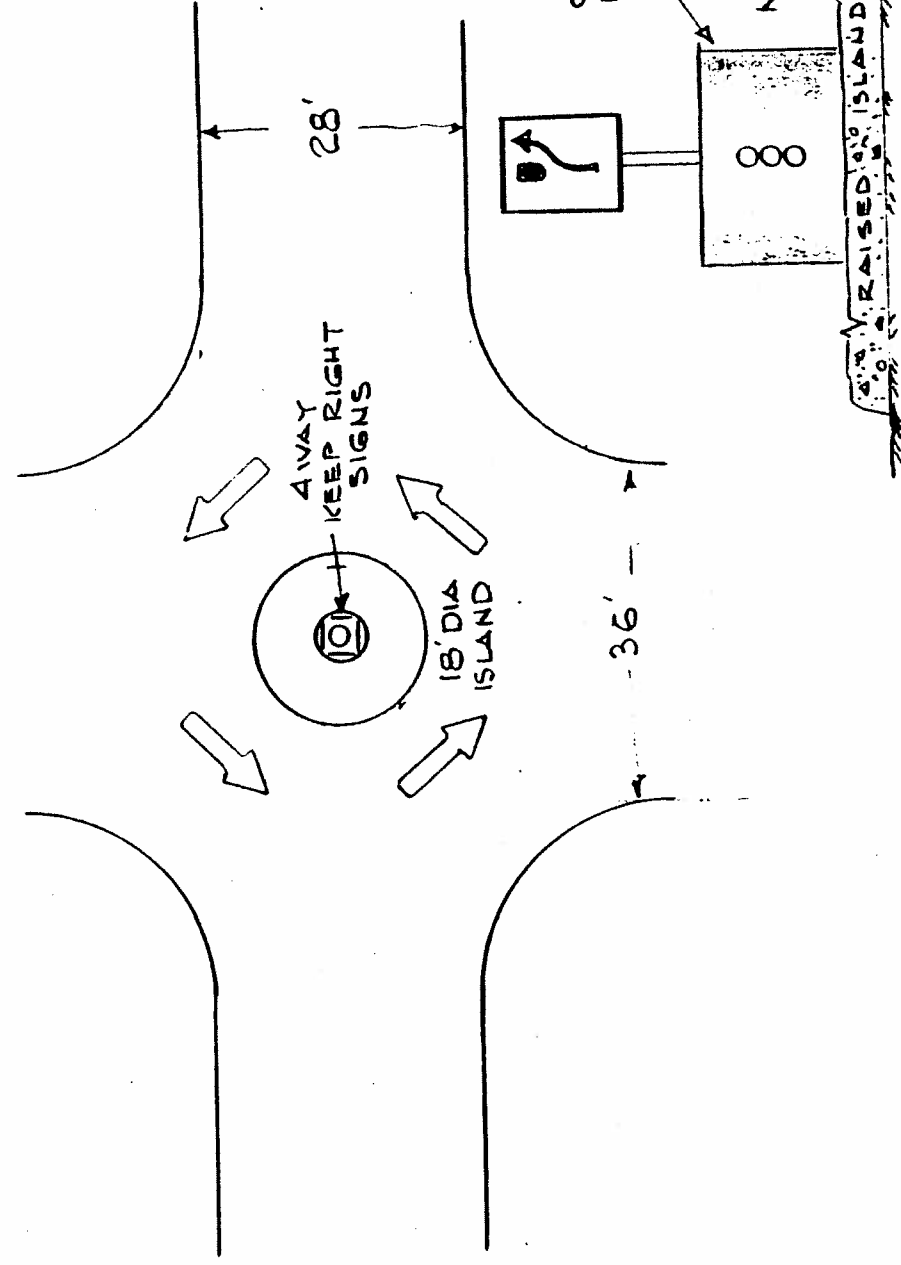
RAISED ISLAND TURNAROUND TRAFFIC CONTROL.

1. CURB OF ISLAND TO BE PAINTED YELLOW
2. KEEP RIGHT SIGN TO FACE EACH APPROACH
3. 3 LENS REFLECTOR ON ISLAND TO FACE EACH APPROACH
4. PAVEMENT ARROWS AS INDICATED.

'THAT staff be instructed to design a small traffic circle and that the design then be referred to the Traffic Safety Committee, along with the matter of the feasibility of constructing and monitoring such traffic circles, on an experimental basis, at specific intersections with the location(s) to be selected by the Traffic Safety Committee. And further that the recommendations of the Traffic Safety Committee be brought forward to Council for the Council member's consideration prior to any implementation.'
