ITEM 9
MANAGER'S REPORT NO. 49
COUNCIL MEETING 87/08/10

RE: CAPITOL HILL CONSERVATION AREA

TO: MUNICIPAL MANAGER 1987 August 05
FROM: DIRECTOR PLANNING & BUILDING INSPECTION Our File: 10.250
"Capitol Hill"
SUBJECT: CAPITOL HILL CONSERVATION AREA

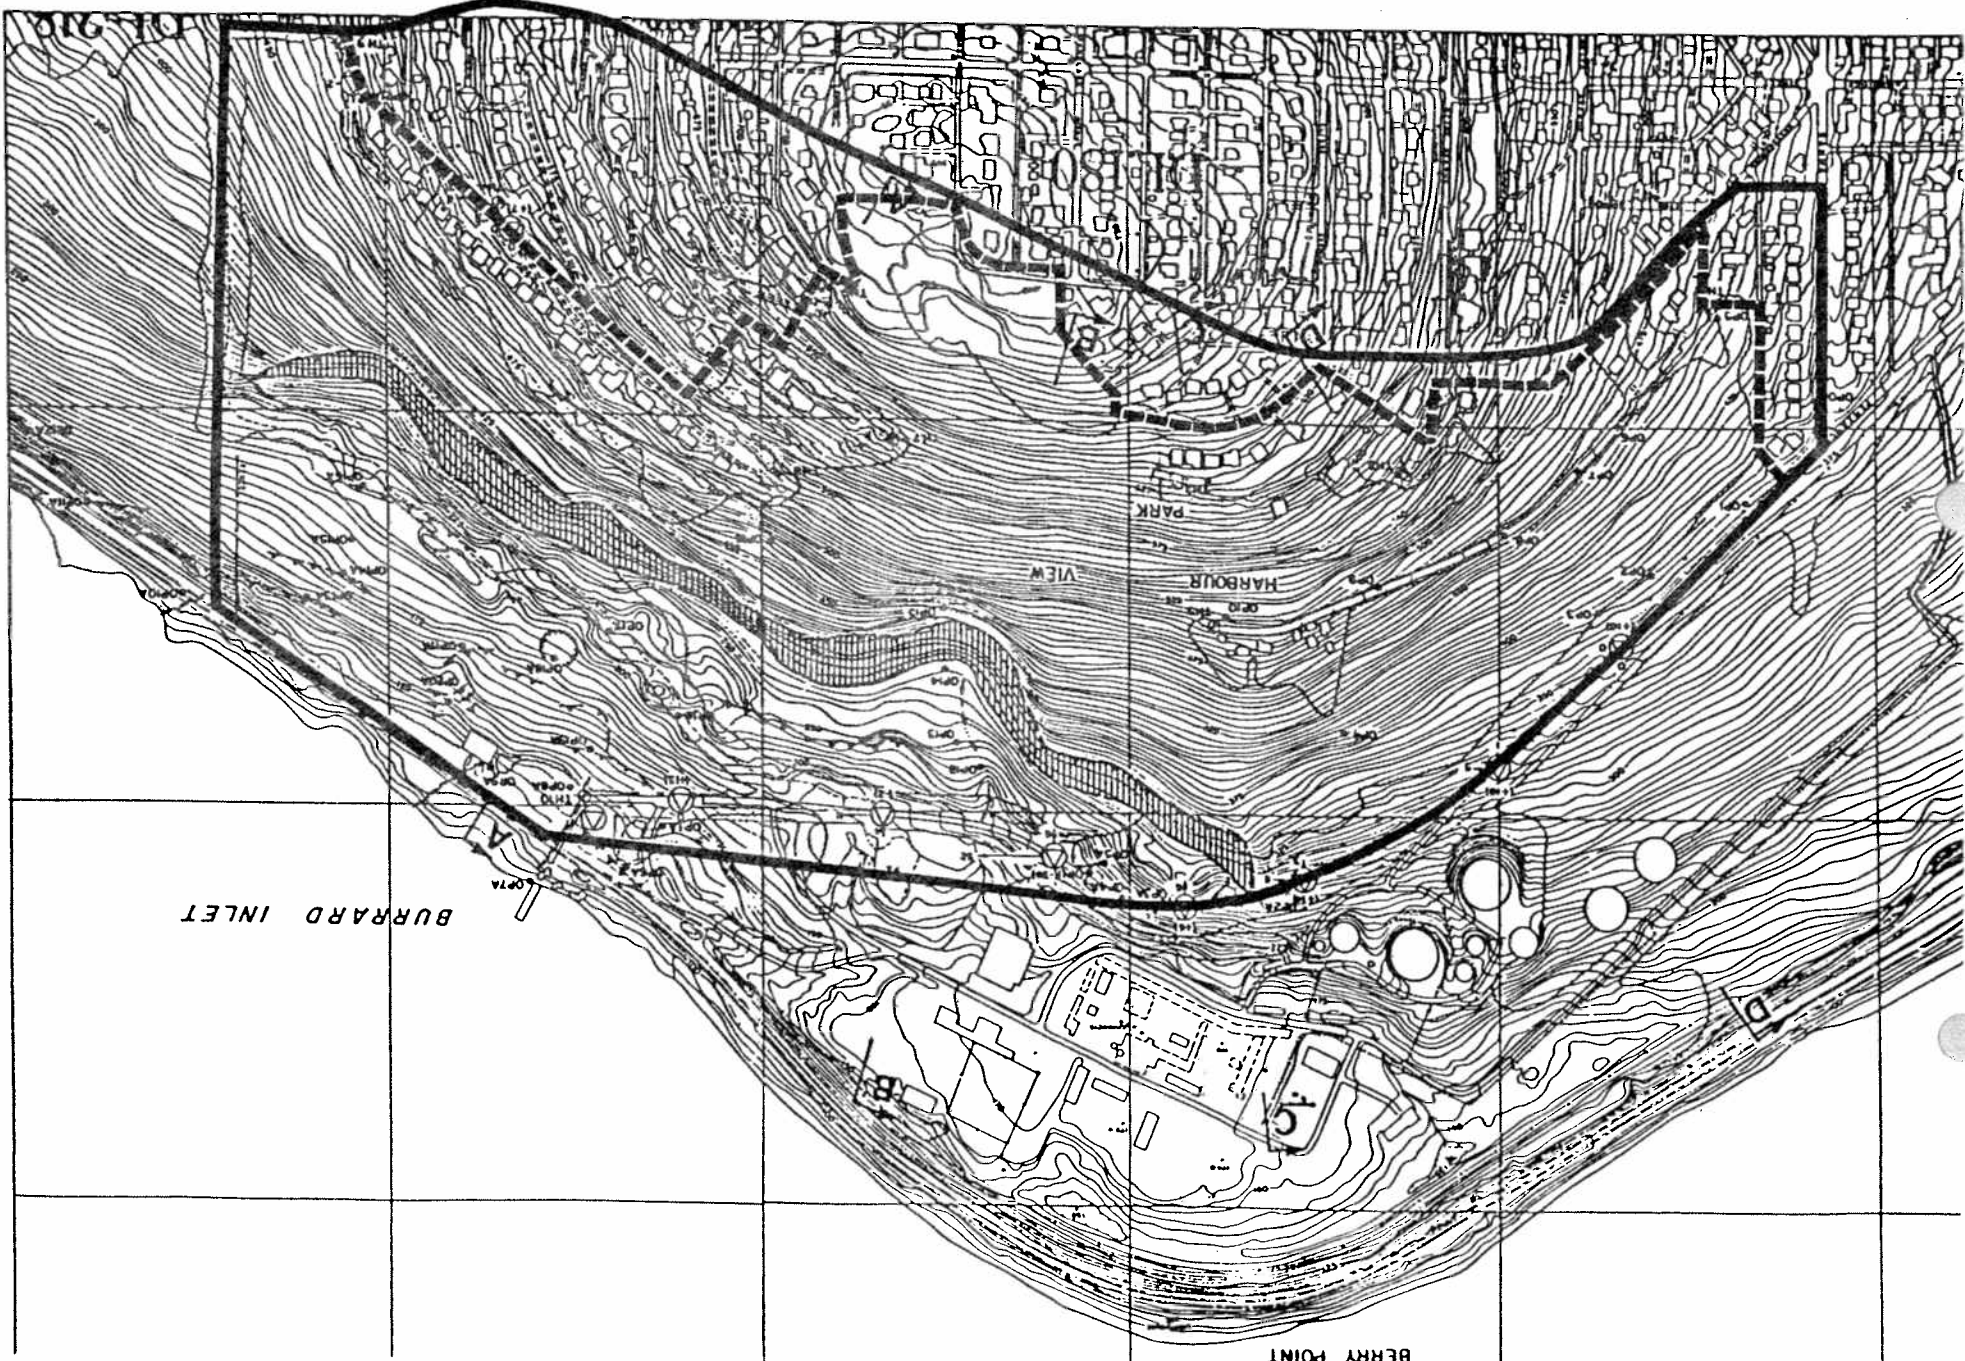
TOPOGRAPHY

BERRY POINT

As documented in a report prepared for the District of Burnaby by Dames & Moore, a landslide occurred on 1975 December 02, on the Goodwin Johnson Limited property. Horizontal and vertical movements of more than 10 feet occurred across the CPR tracks. Damage to existing structures included loss of support to the north-west corner of the building located in sub-area 4 and loss of a portion of the dock located north of sub-area 3 and outside the Conservation Area.

The consultant has confirmed that this region is not suitable in its present condition for development. The cost of stabilizing all or portions of this area would be "very large" due to the estimated depth and extent of the ancient slide.
