TO: MUNICIPAL MANAGER  
FROM: APPROVING OFFICER  
SUBJECT: SUBDIVISION REFERENCE #72/91  
D.L. 57, Lot 278, Plan 35621  
2820 Underhill Avenue  
SEARS WAREHOUSE SITE

PURPOSE: To obtain Council approval for the piping of portions of two watercourses traversing the subject site.

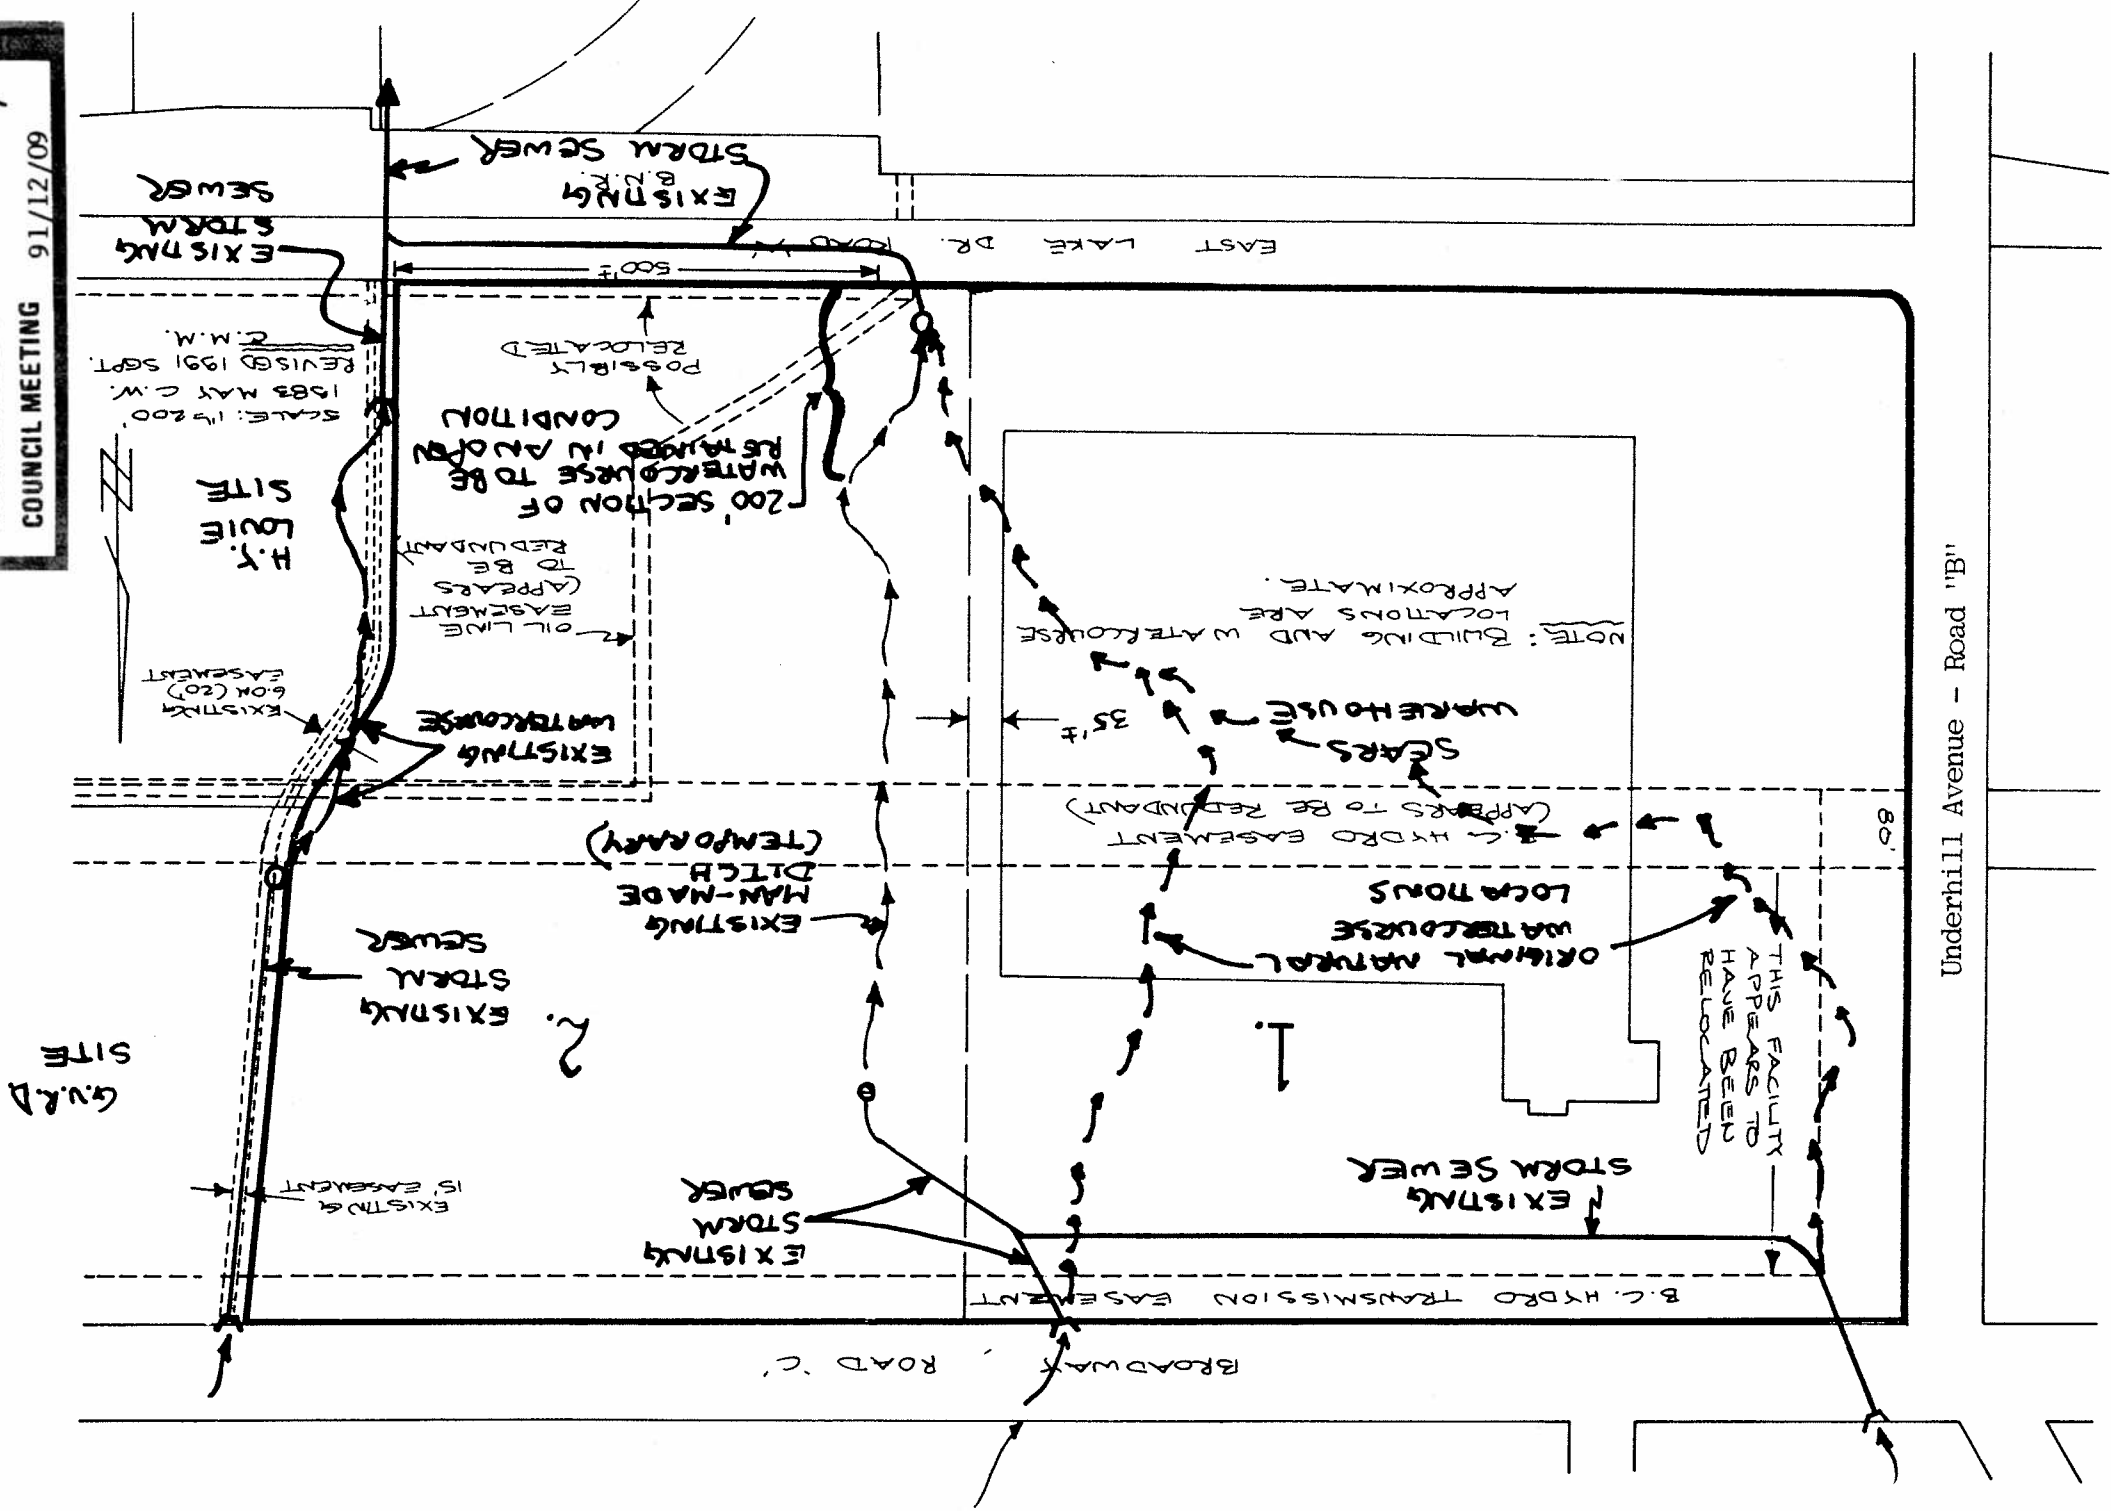
S. D. REF. # 72/91  
 X. REF. S. D. REF. # 39/83  
 123

Underhill Avenue - Road "B"

- 2.1 The Planning and Building Department received an application for subdivision of the subject property into two lots under the existing M3 zoning as shown on the attached sketch. The westerly portion of the site (proposed Lot 1) contains the existing Sears warehouse. The easterly portion (proposed Lot 2) is vacant and there are two watercourses traversing this section of the site.
