**SUBJECT: CHEVRON CANADA REFINERY - ODOUR INCIDENT**

**PURPOSE:** To provide Council with information on the odour incident at Chevron Canada Refinery between September 10-12, 2004.

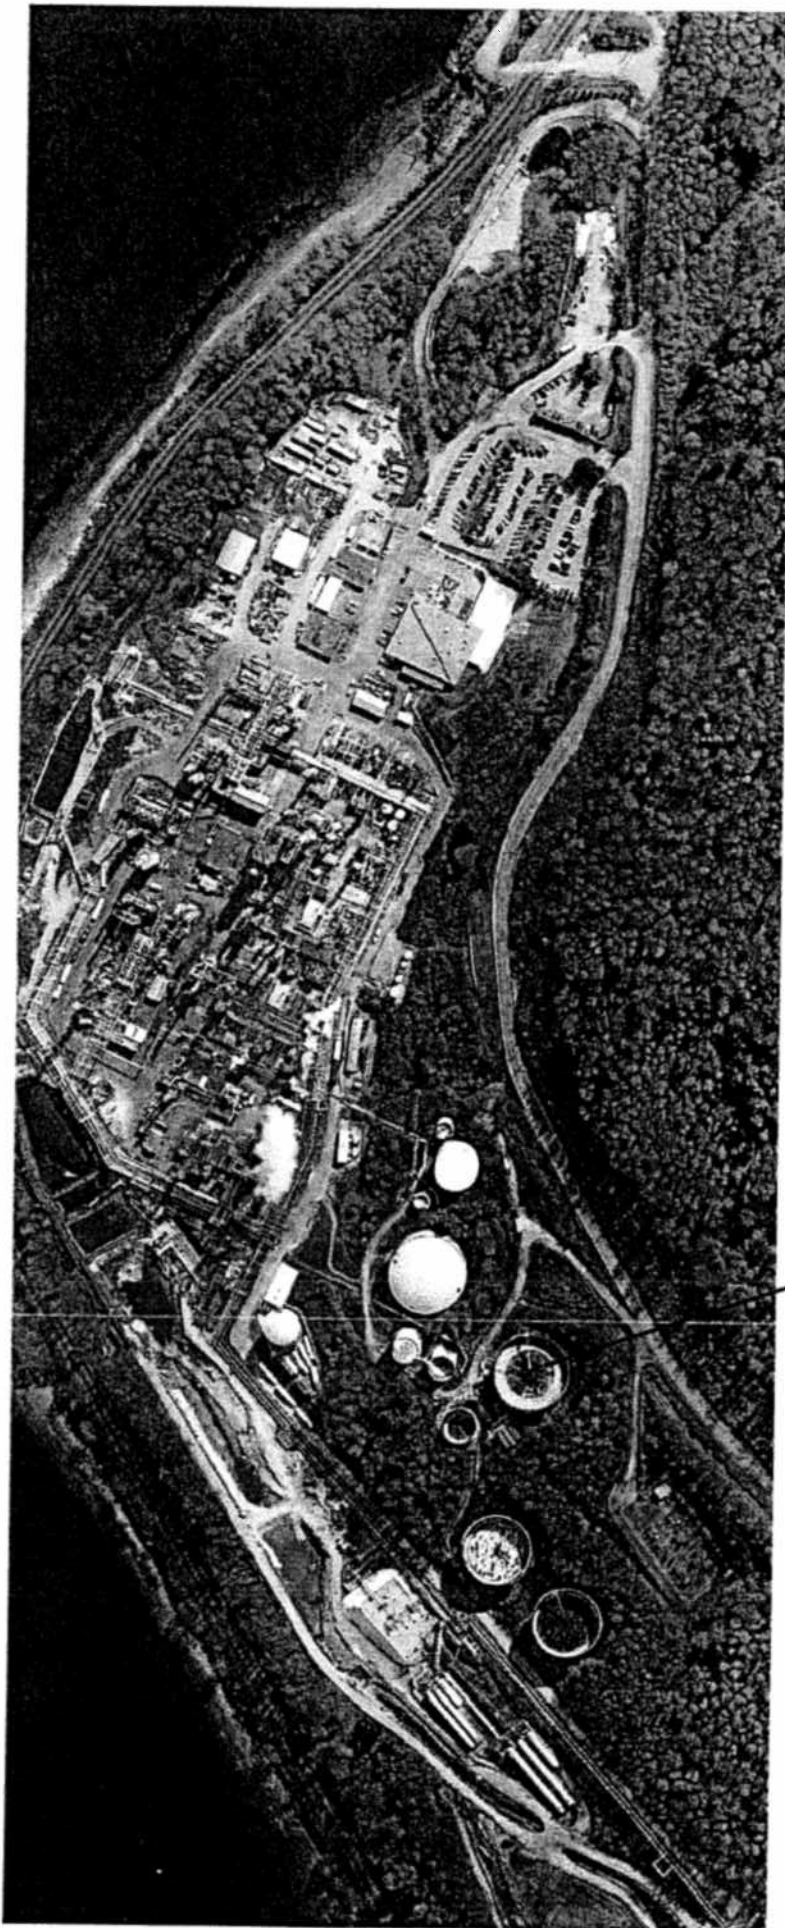
On Saturday, September 11, 2004, inspection by the GVRD and Chevron staff identified the source of the odours to be from Tank #1003, a floating roof intermediate feedstock storage tank located in Area 2 (see Attachment #1). The cause of the odour was determined to be an obstructed floating roof water drain line. As a result of the obstruction, some liquid feedstock in the tank had been displaced onto the roof, resulting in the generation of odours. A temporary odour suppression system was put in place and activated to reduce the odours while remedial work continued.
