**SUBJECT: PRESERVATION AND REPAIR OF CENOTAPHS AND HERITAGE  
LANDSCAPE FEATURES**

**PURPOSE:** To provide an update on work underway to preserve and maintain cenotaphs and heritage landscape features that have been identified as civic heritage resources.

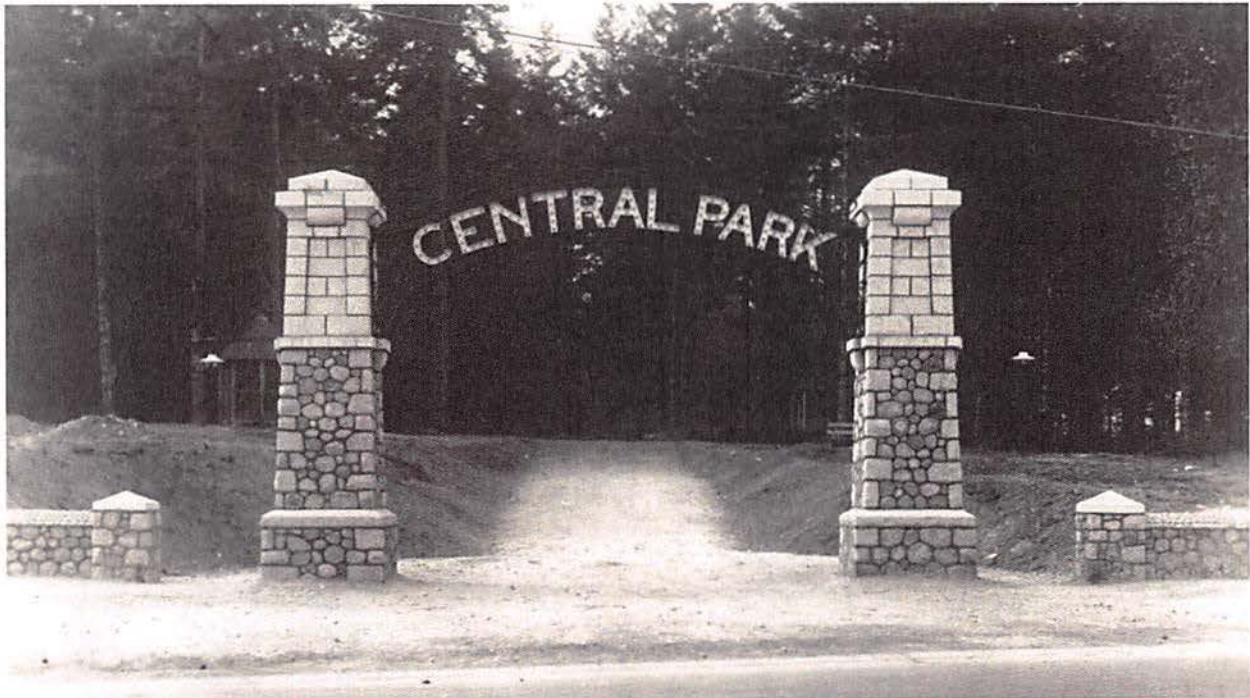
*Attachment #1*

The Central Park Entrance Gate in 1914, shortly after it was constructed. A lit sign was mounted on a wrought iron arch between the gate pillars (CBA 449-002)

The Central Park Entrance Gate was constructed in 1913 by B.C. Electric Railway in exchange for additional right of way within the park. It consists of two massive stone pillars that originally supported a decorative wrought-iron arch with a lit sign that read “Central Park” (see *Attachment #1*). The resource also includes adjacent gate posts, and a low flanking stone wall with a cobblestone cap that curves into the park to the east (see *Attachment #2*).

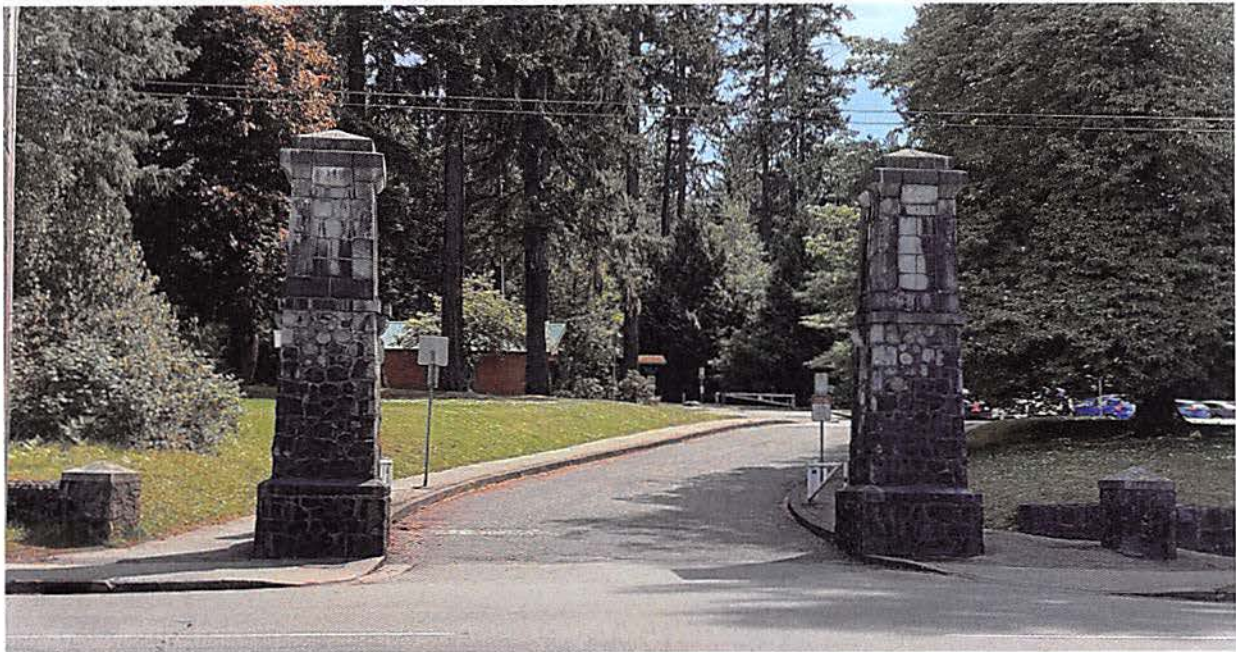
Current condition of the Central Park Entrance Gate pillars

The priority repair work identified in the Iredale Report for the gate pillars and posts includes extensive repointing of mortar joints, cleaning and application of a rust-proof finish to iron elements, and overall cleaning to remove organic material. The masonry work will be performed by a skilled heritage mason, following specifications developed by a heritage consultant.

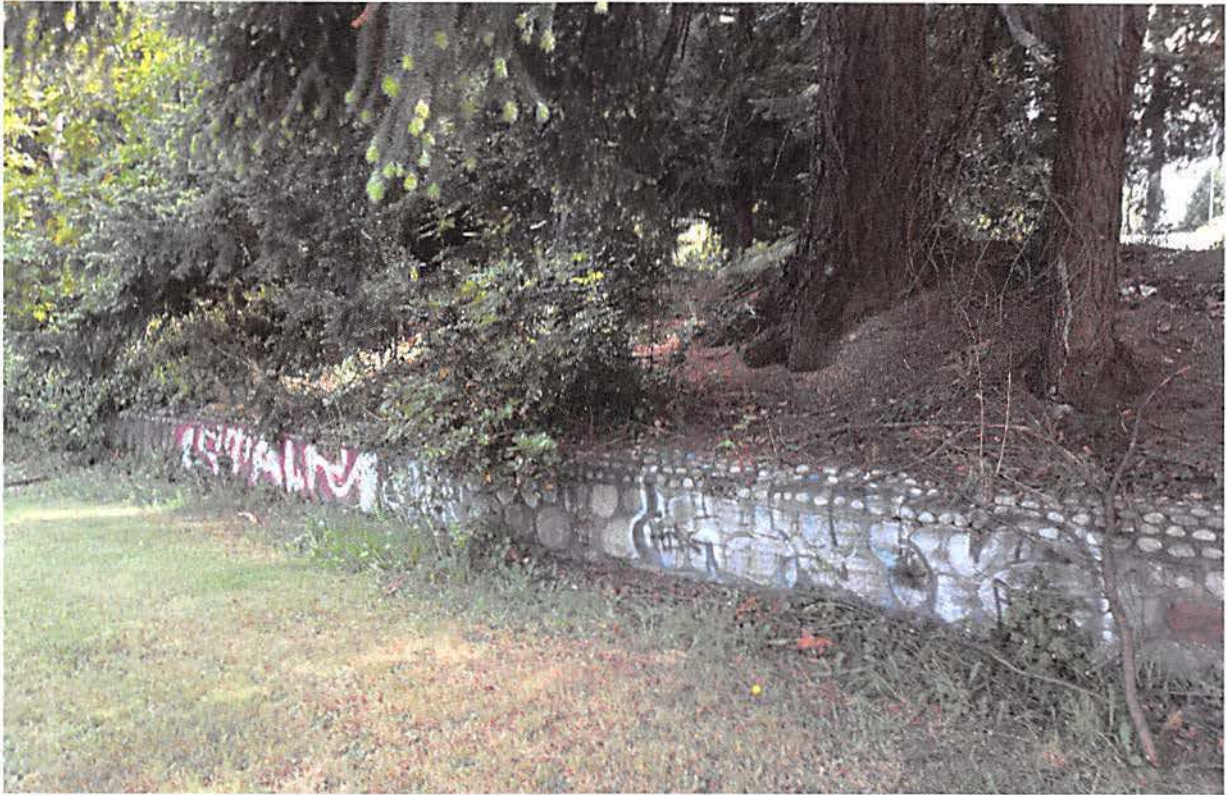
Flanking wall of the Central Park Entrance Gate feature

The flanking wall requires repointing and repair of mortar, and cleaning to remove graffiti and organic material. Significant decay was noted in the flanking wall, particularly at the south end where it makes a 90 degree turn to the east (see *Attachment #3*). The 90 degree turn marks the site of the original B.C. Electric Railway interurban station on the west side of the tracks.

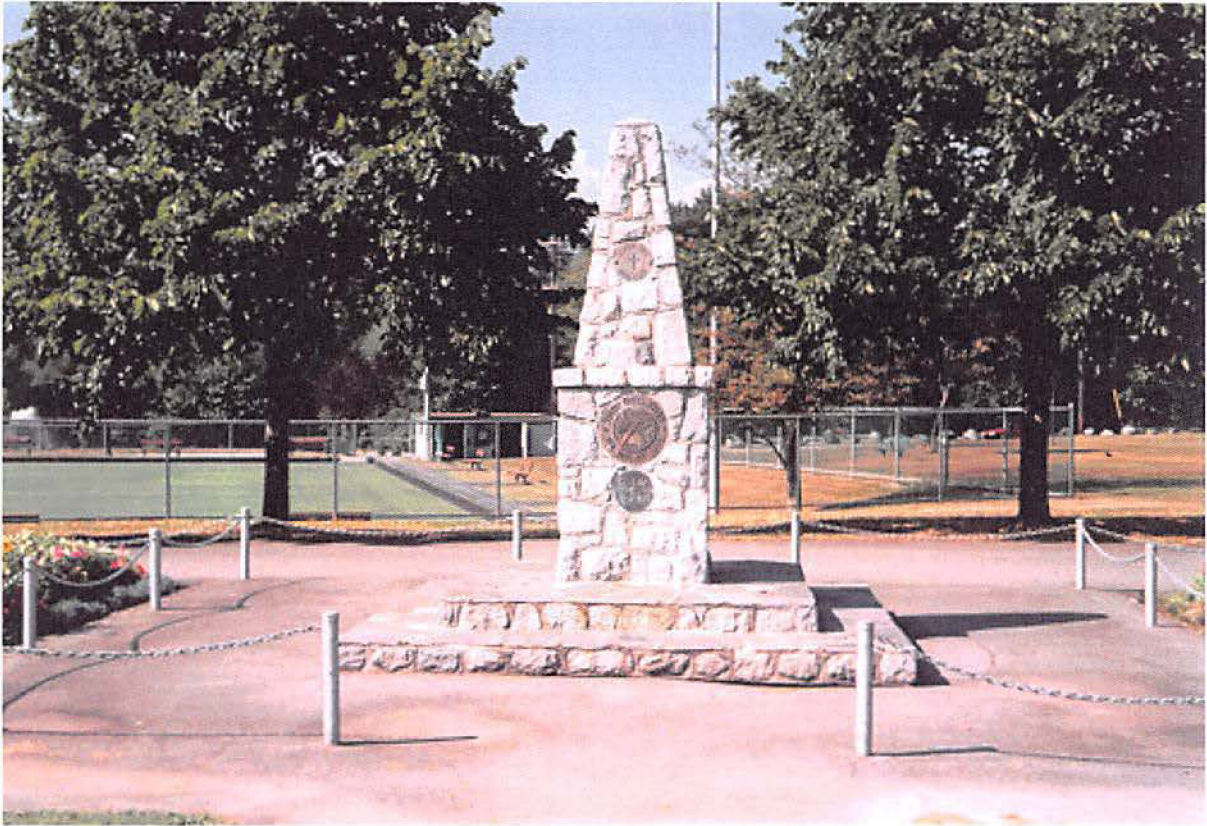
The North Burnaby Cenotaph was constructed in 1953 and is a protected heritage resource designated by Bylaw 9807 in 1992. The priority work identified for this resource is repointing of its mortar joints. The report also noted the original granite steps of the monument have been covered in slate (see *Attachment #3*). While the slate is stable and in good condition, future consideration could be given to removing the slate to restore the original condition of the monument.

The North Burnaby Cenotaph

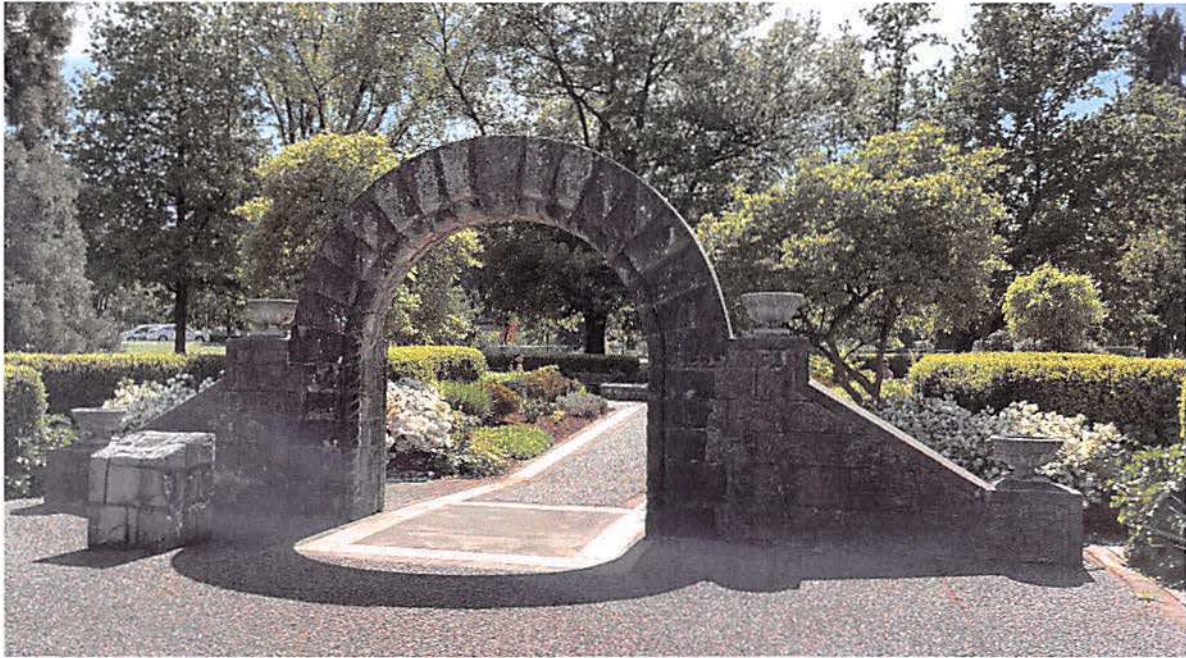
The Jubilee Grove Arch at 3883 Imperial Street is a ceremonial arch located at the corner of Kingsway and Patterson in Central Park (see *Attachment #4*). It was dedicated in 1935 in preparation for the celebration of the Jubilee of the coronation of King George V, and completed in 1939. The sandstone arch element was salvaged from a Vancouver building that had been demolished, and much of the labour to install the arch was performed by relief workers in Burnaby during the Great Depression. The resource was protected through Heritage Designation Bylaw 9807 in 1992.

As part of regular review and maintenance, staff observed fractures and cracks in the arch feature and deterioration of the mortar. As a result, heritage consultant team McGinn Engineering & Preservation was retained to review the resource and provide costing and specifications for repair. Required repairs include:

The Jubilee Grove Arch

- **Structural stabilization of the arch feature:** rods will be inserted above the side piers of the arch structure and strength will be added to the inside soffit of the arch to increase stability.
- **Repointing the arch and flanking walls:** the mortar joints will be refilled to protect the resource from water ingress.
- **Repair and cleaning of the stone and masonry:** areas where there has been loss of sandstone will be patched, and the entire structure will be cleaned, including the granite flanking walls and the plaza and fountain area.

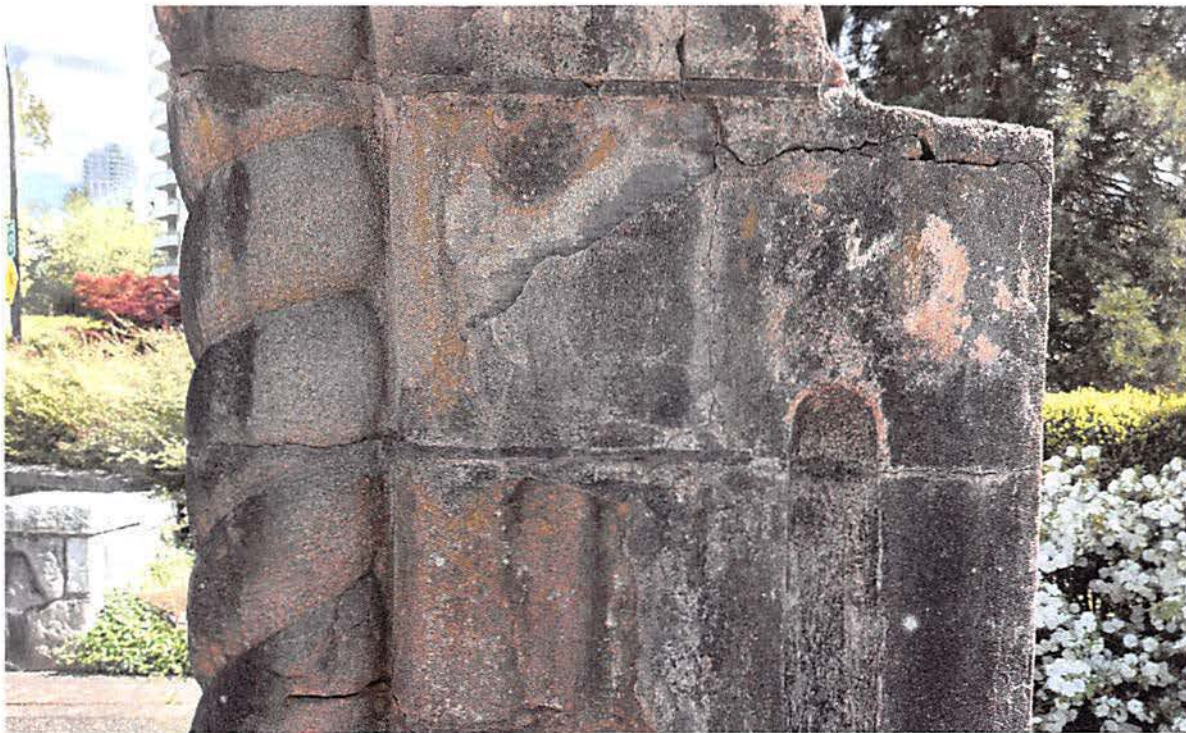
Detail image of area to be repaired through repointing of masonry and stabilization to prevent fractures

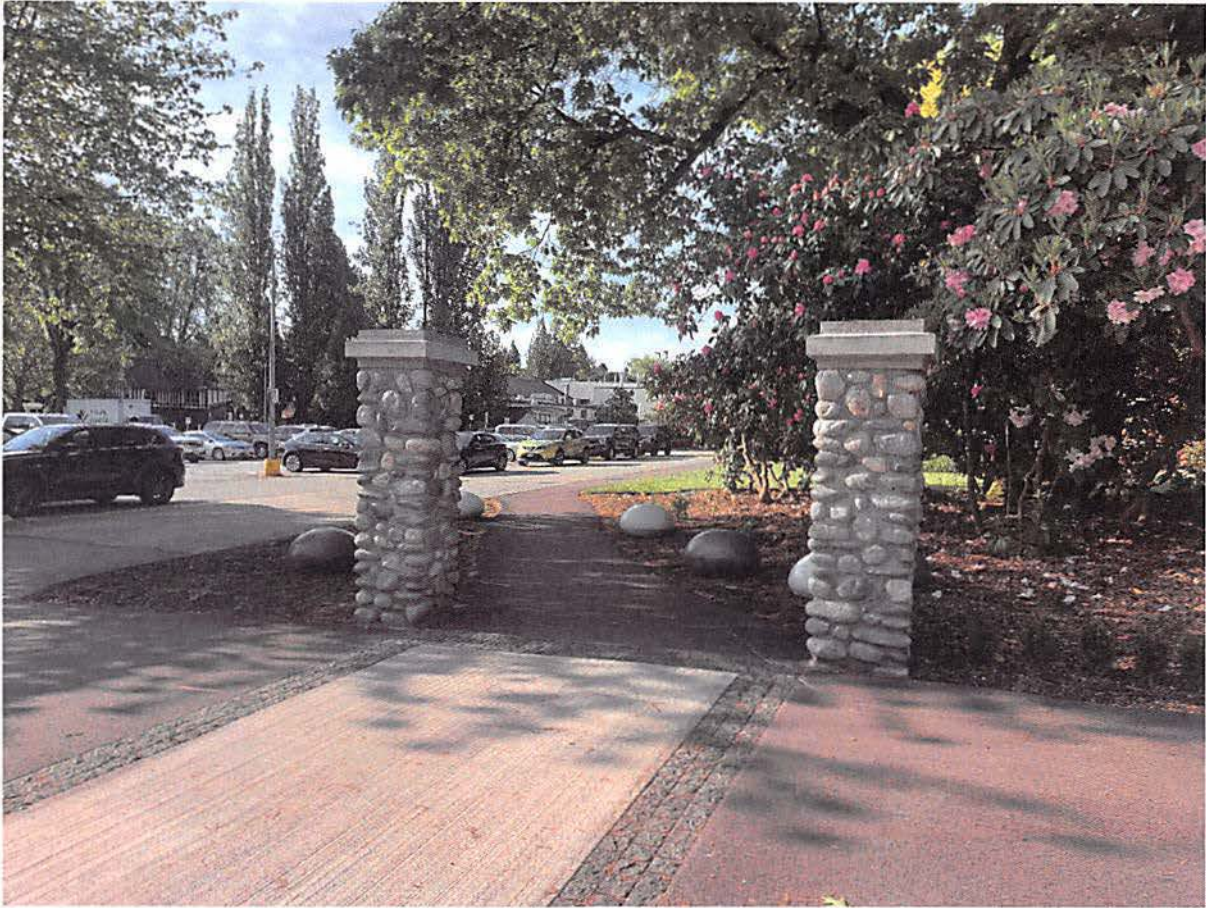
Recent paving and urban trail upgrades to Deer Lake Avenue included installation of replica Estate Gate pillars at the location of the eastern end of the original driveway entry to the Fairacres Estate (see *Attachment #5*) and re-grading of the area adjacent to the surviving gate pillar at the original location of the western entrance to the driveway to the Fairacres Estate (see *Attachment #6*). The re-grading at this location eliminated a step, making this pathway an accessible pedestrian entry to the estate grounds. A new entry path was poured in asphalt as a temporary condition, to enable future upgrades to the path and associated landscaping in conjunction with conservation of the Fairacres Estate Gate.

Replica gate pillars adjacent to the driveway to the Shadbolt Centre surface parking lot

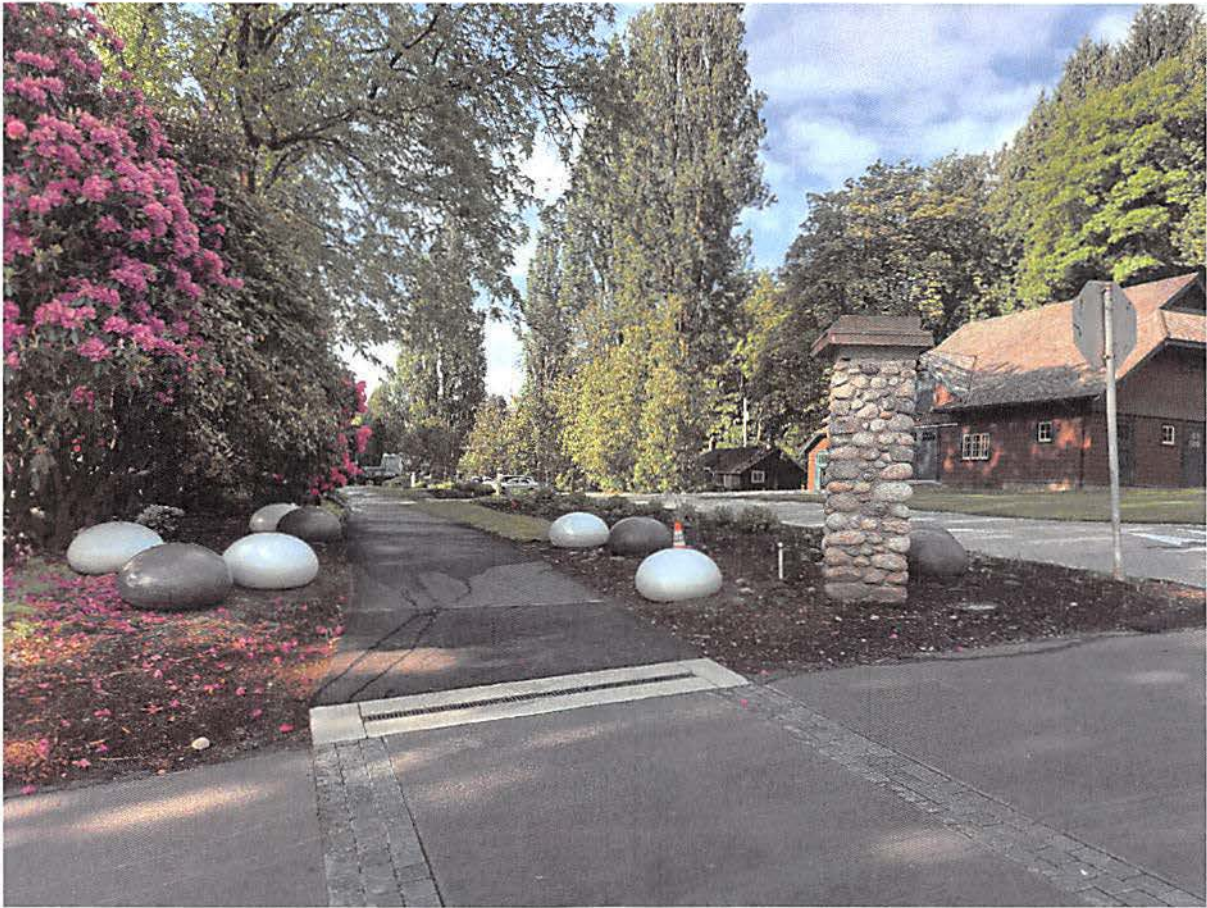
*Attachment #6*

Extant gate post adjacent to the entry driveway to the Burnaby Art Gallery parking lot

Further conservation and interpretation planning for the Fairacres Estate and its heritage landscape features will include development of a conservation plan to restore the original entry gate at the western end of the original driveway, including reconstruction of the missing gate pillar and replacement of the asphalt path at the gate with materials more compatible with the historical

context. The conservation plan will also recommend interventions to repair and conserve the extant gate pillar, and to stabilize and repair the Greenhouse Foundation Wall.

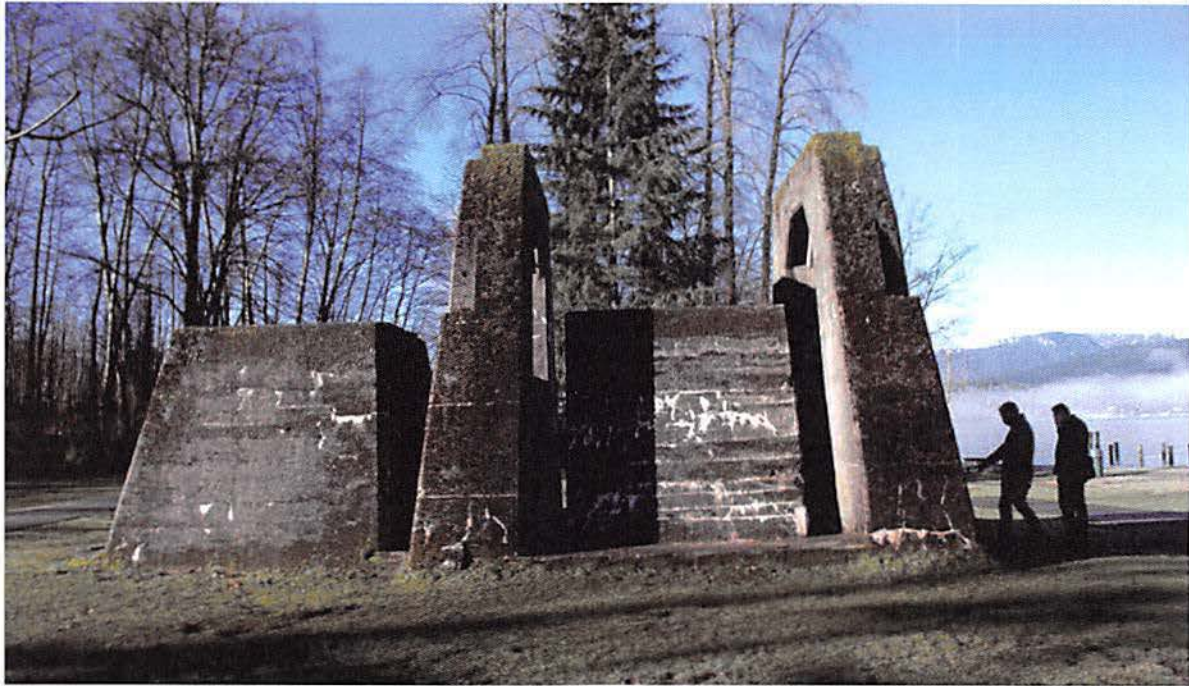
*Attachment #7*

The condition of the North Pacific Lumber Company ruins at Barnet Marine Park were reviewed by Iredale, including the engine stand and the base of the sawmill burner (see *Attachment #7*). These resources are on the City's heritage inventory, but a commitment to their long term preservation has not been made through a heritage designation bylaw.

Engine stand base from the North Pacific Lumber Mill at Barnet Marine Park.

A heritage consultant will be retained in Phase III to guide the City in a process to consider the future retention, interpretation, and use of these resources, including identifying conservation works required for their retention. Recommendations from the study will be advanced to Council upon recommendation of the Community Heritage Commission. Conservation work supported by Council and included in the 5-Year Financial Plan would form Phase IV of the project.

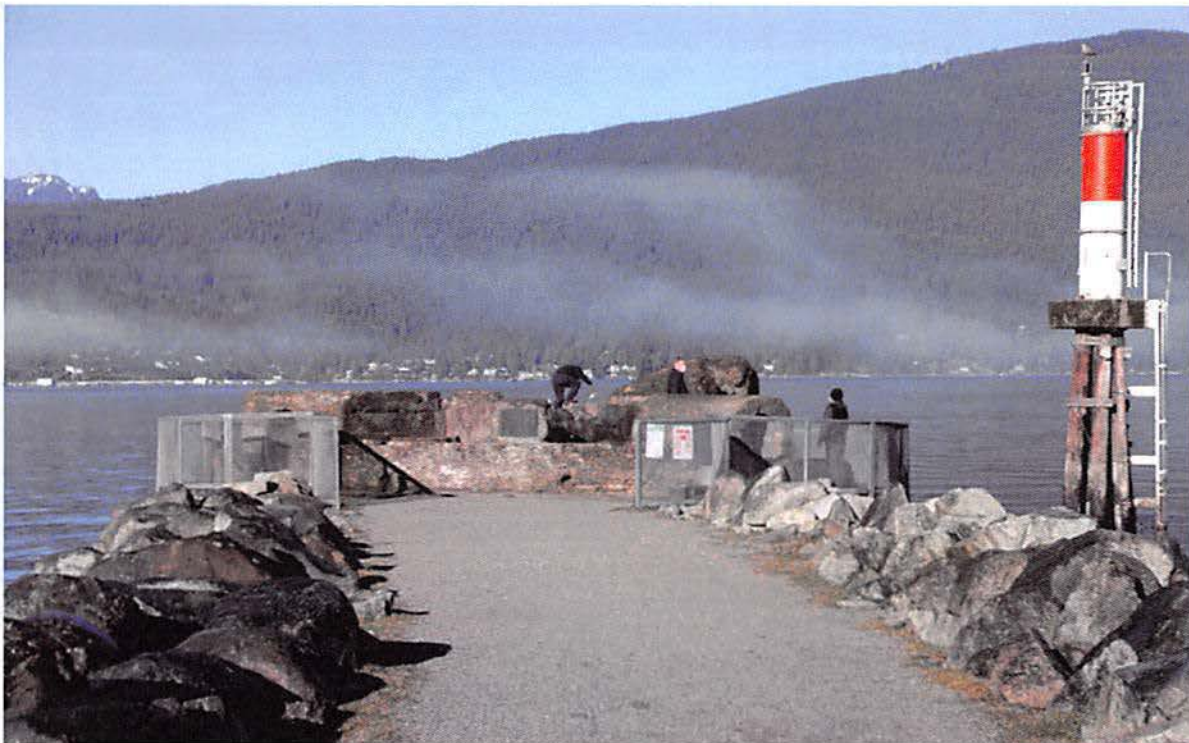
Remains of the sawmill burner from the North Pacific Lumber Mill at Barnet Marine Park
