**SUBJECT: HERITAGE REVITALIZATION AGREEMENT/HERITAGE DESIGNATION BYLAW, ALICE AND ROBERT TRAVERS RESIDENCE, 7828 STANLEY STREET**

**Heritage Conservation Plan  
Arthur Long Residence  
7828 Stanley Street  
Burnaby, BC**

**May 2021  
Updated January 2023**

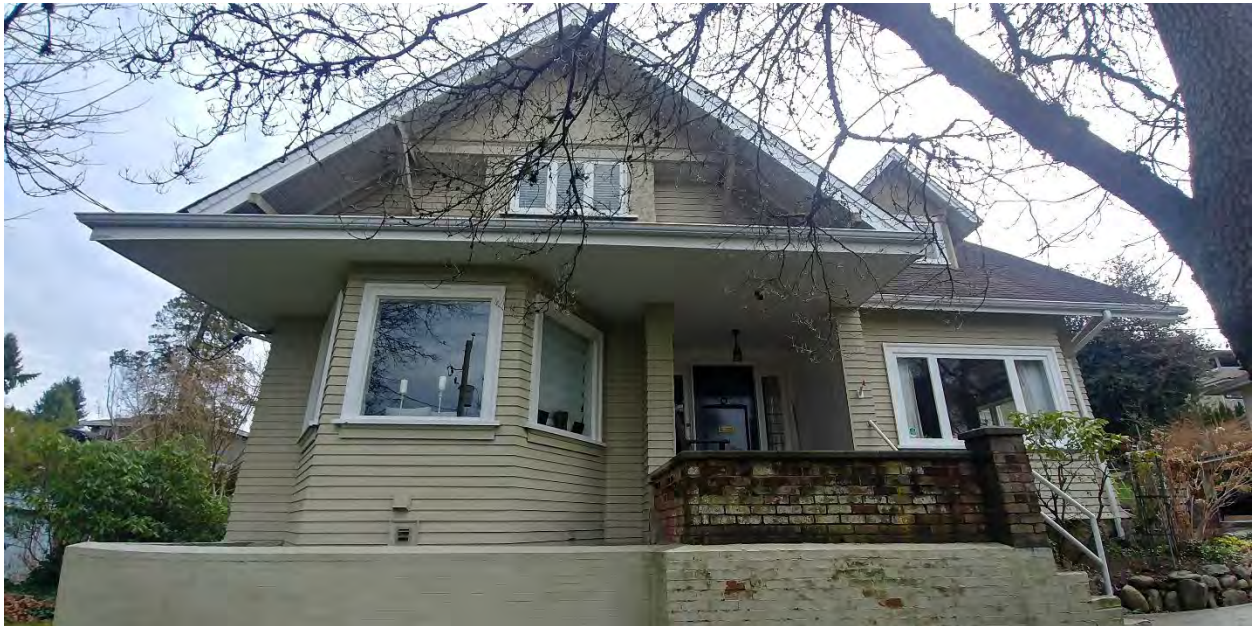
*North (front) elevation*

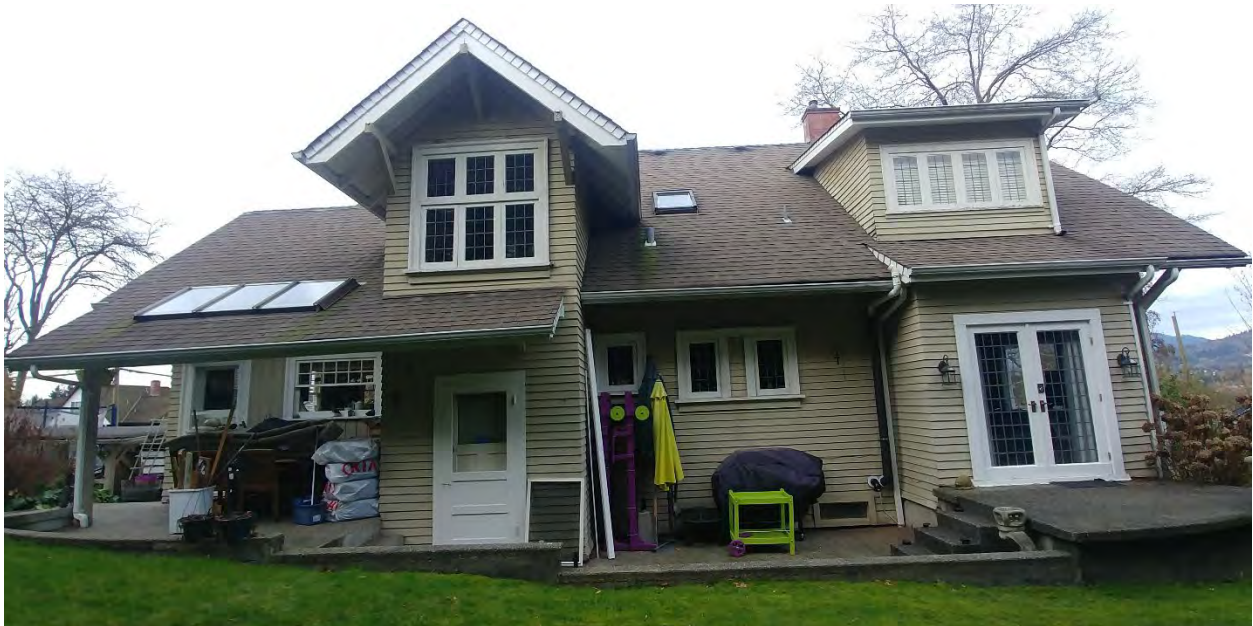
*South (rear) elevation*

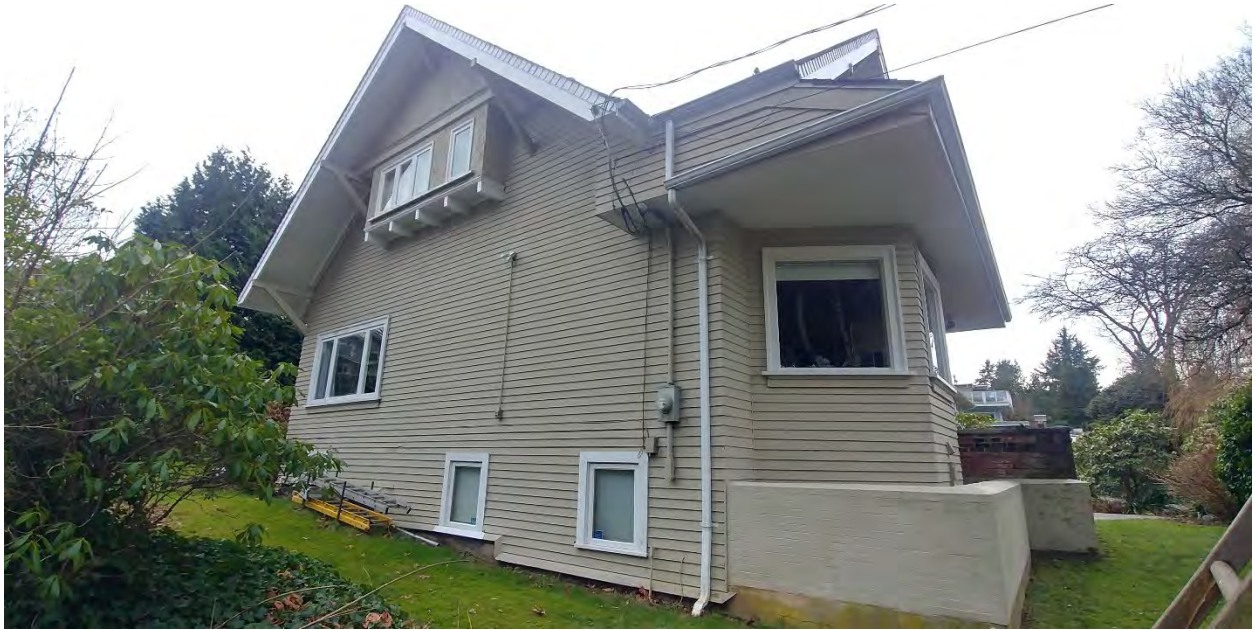
*East elevation*

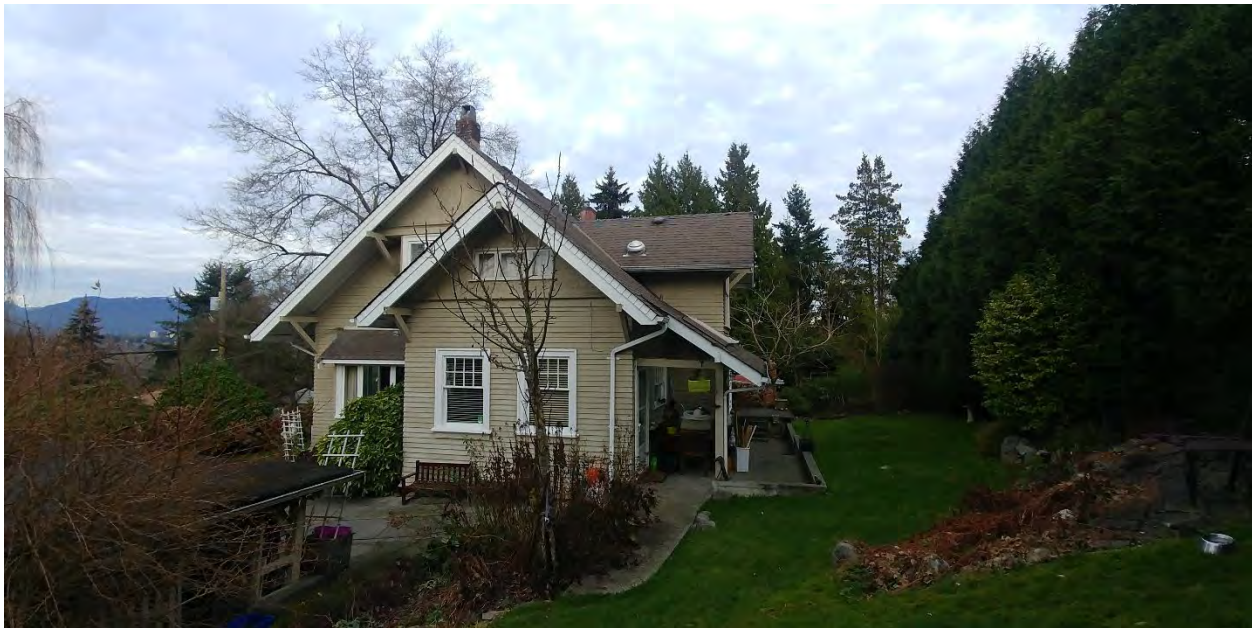
*West elevation*

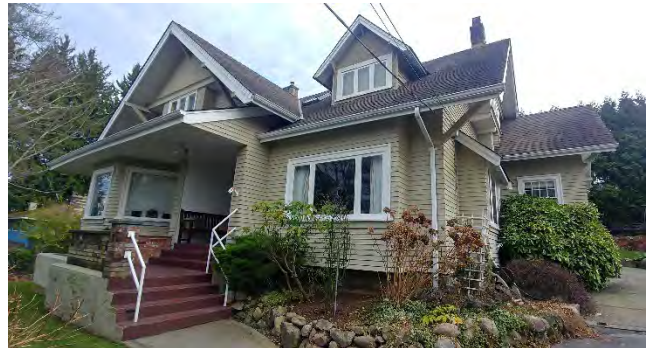
The form, scale and horizontal massing of the house, as expressed by its two-storey height, steeply-pitched cross-gable roof with dormers, and the multi-planed façades with bump-outs and projecting bays are all character-defining elements.

The overall form, scale and massing identified as character-defining elements will be retained.

Relocation of the house elsewhere on the lot might damage this aspect of the design and should therefore be avoided; however, carefully lifting the house (up to a maximum of two or three feet) would be reasonable provided extra caution is taken to protect these flare elements. If raising the house would mean losing the flares, then they should be carefully documented and replicated afterwards (in terms of design, size, profile and material).

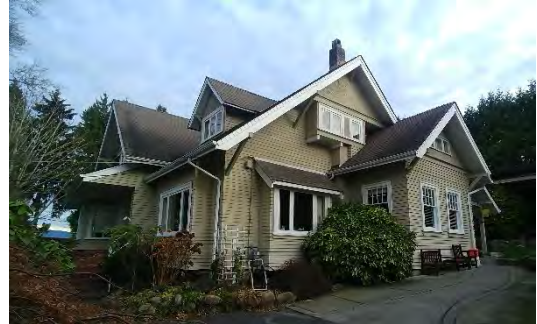
The roof and its design will be retained. It was not possible to inspect the condition of the roof for this report, but from the ground the material appears to be in good condition. A qualified person with the proper equipment should inspect the asphalt shingles for wear and tear, damage, and for missing pieces as part of the maintenance routine. It is appropriate to replace the asphalt shingles with new asphalt shingles when required.

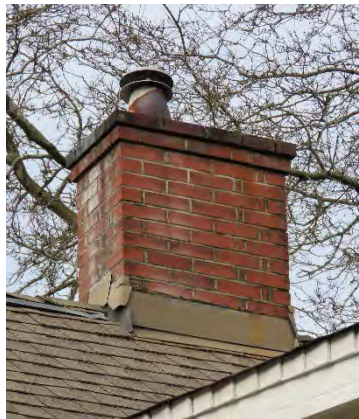
The chimney on the east side of the house is a rectangular shape, is comprised of brick in a Flemish garden wall bond style, and has a corbelled chimney cap, as well as a vent. The chimney on the west side of the house is square and comprised of brick in a running bond pattern and is topped with a square chimney pot.

*Chimney on east side of the house.*

The chimneys appear to be in good condition but should be inspected at some point by a qualified mason who can assess the condition of the overall chimneys as well as individual components such as the bricks, grout, flashing, and whether or not there is any moss growth. The chimney on the west side

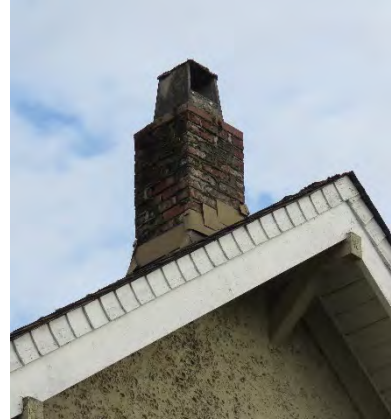
*Chimney on west side of the house.*

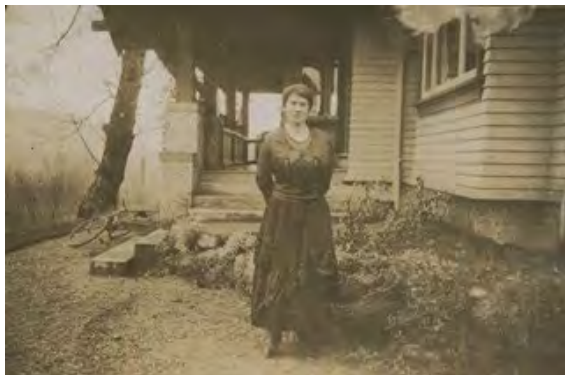
The existing front porch is not the original. At some point in the past, the original porch was removed and replaced with concrete steps and decking. The roof over the porch was also changed at some point. According to historic photographs, the original roof had deep-set eaves and was supported on square wooden posts.

*Photo of Alice Travers standing in front of the original front porch, 1921.*

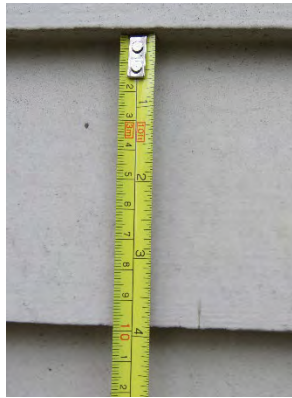
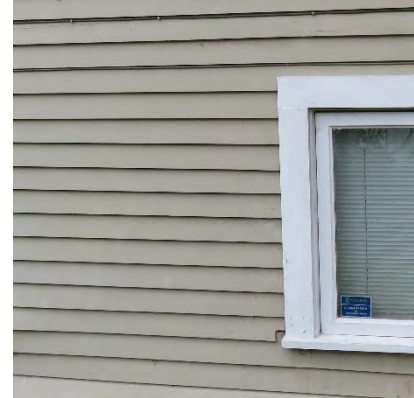
The side elevations are clad in what appears to be the original clapboard siding with a 4-inch profile and should be retained. The siding is in good condition.

If individual boards become damaged or fail in some way over time, it may be possible to repair or replace just those individual boards. Upon removal, special attention should be given to the condition of the material underneath to determine if there is any water damage or other damage to the underlying material which explains why the board(s) failed. The situation should then be corrected. Any replacement pieces should match the existing in terms of design, size, profile and material. The goal is to avoid the appearance of patching.

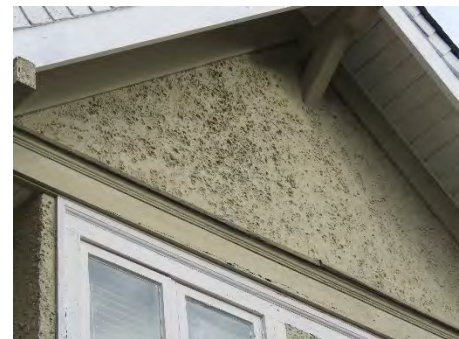
*Stucco:* The stucco appears to be in excellent condition. Regular maintenance of the stucco will be important. Damage tends to occur when water infiltrates the material. Because stucco can be difficult to repair, it is important to hire a professional and skilled plasterer to carry out repair work. More detail is available in the section on Maintenance, but in summary, ensure that repaired or new stucco matches the original stucco in terms of strength, composition, colour and texture.

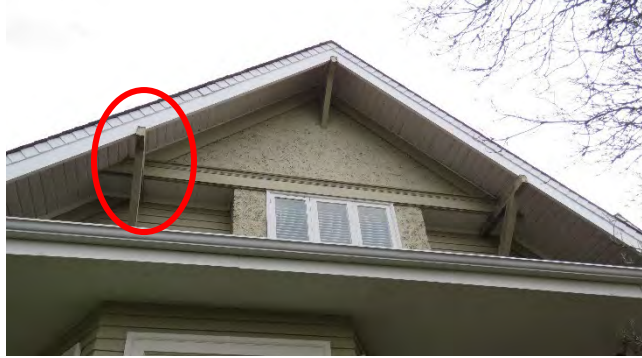
The triangular wooden brackets in the gable ends on all four elevations, that give the appearance of supporting the eaves, look to be in good condition, but a close-up inspection at some point would be a good idea to accurately determine their condition.

If individual brackets are found to be damaged, first try to repair them. If they cannot be repaired, then they should be replaced with replicas that match the existing in terms of design, size, profile and material. The goal is to avoid the appearance of patching.

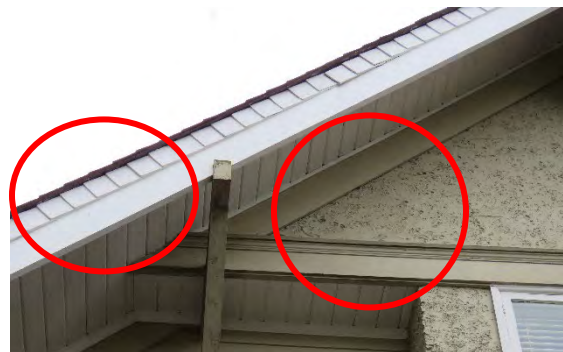
The crown moldings and friezes are simple additions to the elevations that provide a quiet yet effective level of decoration and are in keeping with the intention of the Arts & Crafts style.

They appear to be in good condition, but a close-up inspection at some point would be a good idea to accurately determine their condition. As with the brackets and other original material, any elements that are damaged should first be repaired. If they cannot be repaired, then they should be replaced with replicas that match the existing in terms of design, size, profile and material. The goal is to avoid the appearance of patching.

As with other original material that needs replacing, look at the condition of the material underneath to determine if there is any reason (water damage, for ex.) which explains the damage. Correct the underlying situation before installing the new elements.

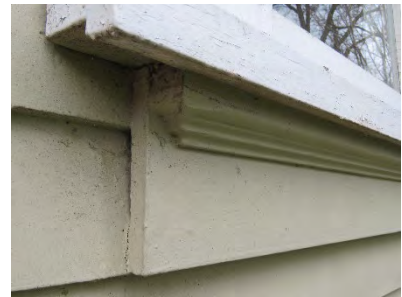
The windows appear to be in good condition. Those on the north (front) and side elevations look to be original and have wood casings and wood frames. Many of them have extra detailing below the sills (see photo at right), which should be retained.

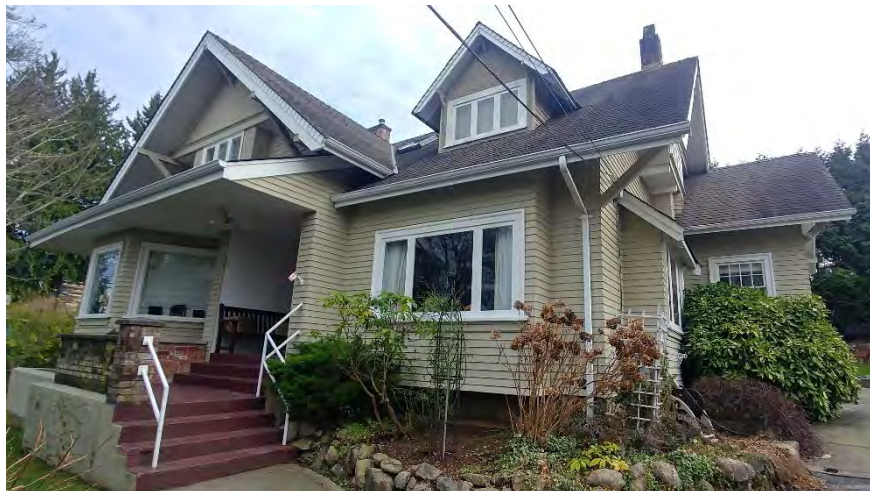
The front elevation has the following types of windows:

- a large, triple sash picture window to the right of the front door
- three single, fixed windows on a three-sided projecting bay to the left of the front door
- a small, triple sash window in a small bump-out in the gable end
- a small, triple sash window in the dormer located on the western side of the front elevation
- a small, single window with a multi-pane upper sash on the large bump-out to the west side of the house

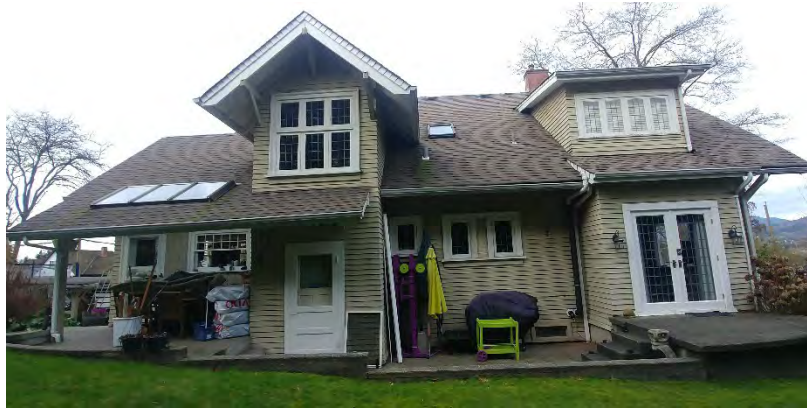
The rear elevation appears to have some newer windows as well as what might be original windows, and consist of the following:

- a single, horizontal window with a multi-paned upper sash on the main level of the west side
- a set of three, single, multi-paned casement windows in the middle of the main level of the elevation
- a large, triple, multi-pane window in the gable dormer
- a quad, multi-pane window in the shed dormer

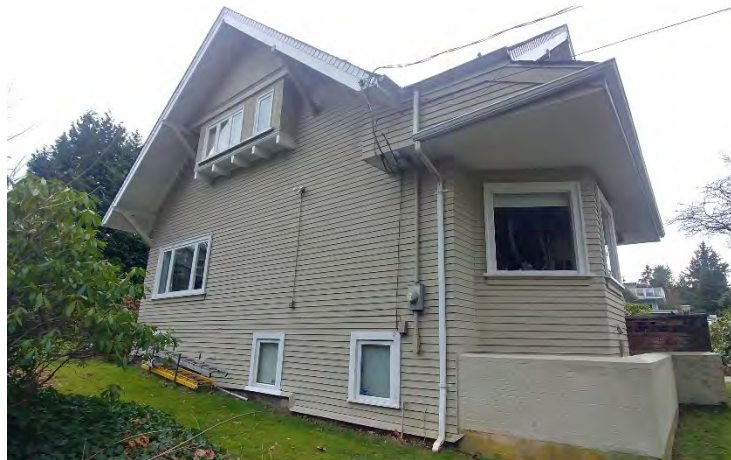
The east elevation has the following window types:

- three, small, square, single windows along ground level
- a medium-sized, triple sash window to the south side of the main level
- a medium-sized, triple sash window and a single window on the bump-out on the upper level

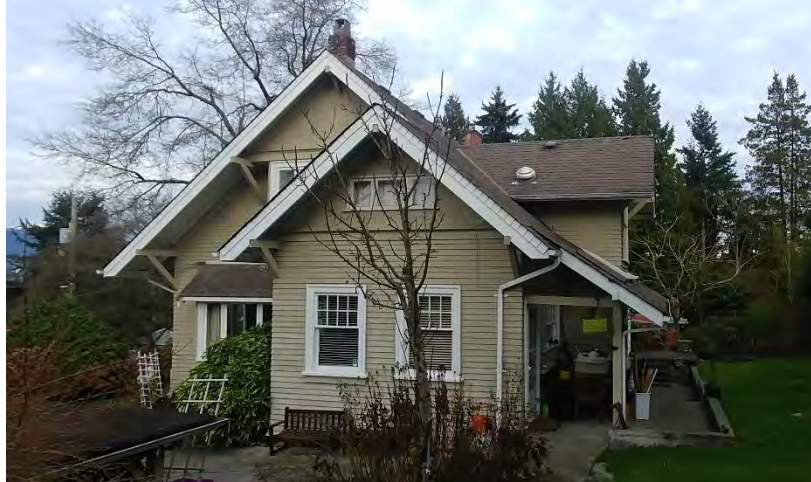
The west elevation has the following window types:

- a medium-sized, triple sash window in the shed bay at the front (north) side of the main level
- two single, side-by-side, windows with multi-pane upper sashes on the main level of the large bump-out
- a medium-sized, double window beside a single window within the same casing on the bump-out on the upper level
- a small, triple window in the gable of the large bump-out

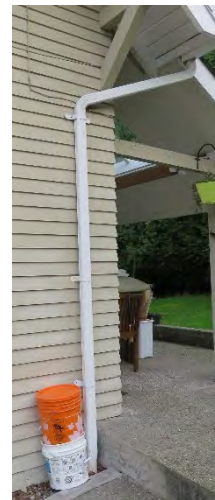
The colour of any new gutters and rain-water leaders should match or blend in with the exterior colour scheme so that they ‘disappear’. The current gutter and rain-water elements are a white colour. Consideration can be given to painting them to match the colour of the cladding at a later time, when the house is re-painted.

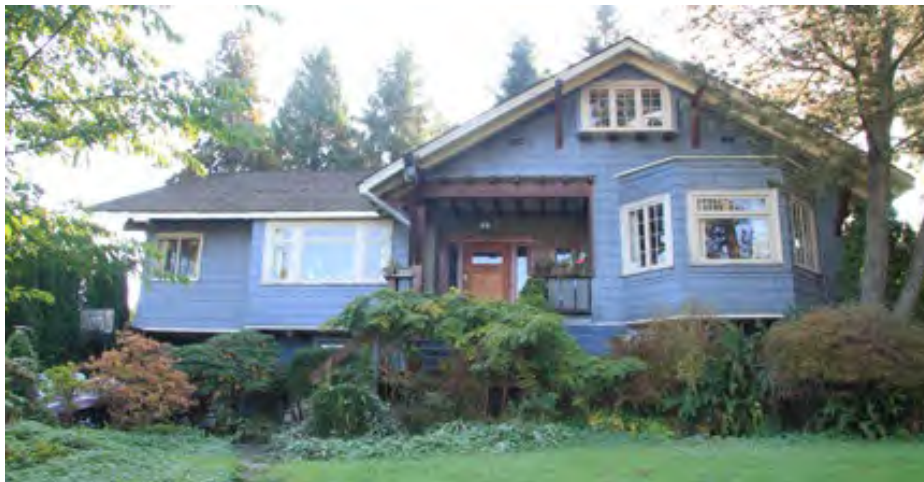
The fact that the subject house and the Ramsay house are almost next door to each other adds to the heritage value of both houses, as it is easy for passers-by to appreciate the two similar designs by this great architect. Some of the similarities between the two neighbouring houses include the dominant cross-gable roof, the triangular eave brackets, the bump-outs, the three-sided bay on the front elevation, and the front door with side-lites.

*Photograph of 7864 Stanley Street, courtesy of the Heritage Burnaby Website, date unknown.*

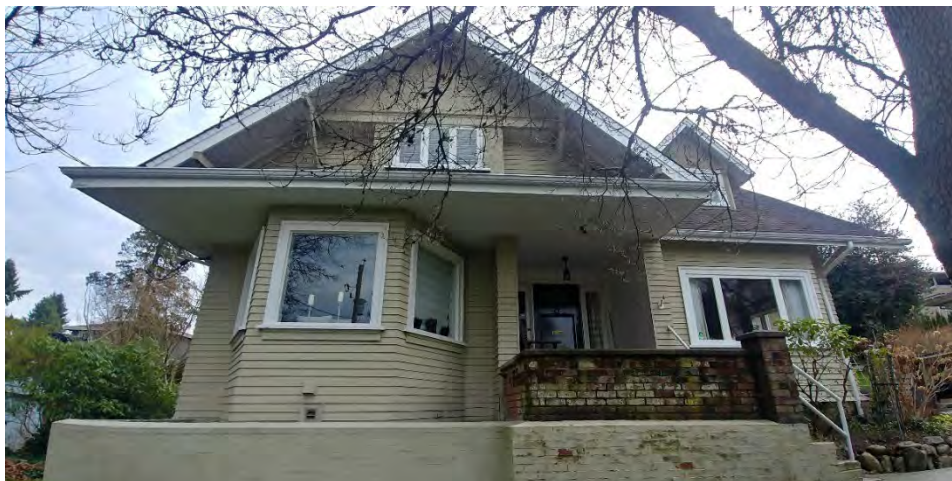
*Photograph of 7828 Stanley Street by the author.*

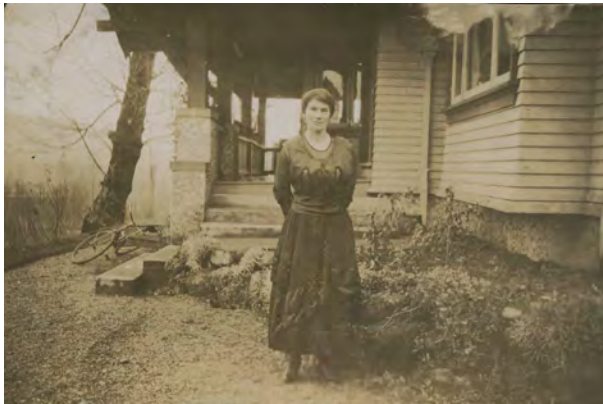
In the photographs below, it is clear that the front porch is now completely different. The original roof has been removed and the porch posts and picket railing system are gone. The stairs are oriented differently, and it is possible that the height of the two deck levels of the porch might be slightly different as well. In the historic photographs, it appears that there are six or seven risers to the porch's lower deck and at least one more to the upper decking. At present, there are four risers to reach the lower decking and a further three risers to reach the upper decking and the front door. With different landscaping and walkway materials being added over time, this is not much of a surprise.

*Photo of Alice Travers standing in front of the original front porch, 1921.*

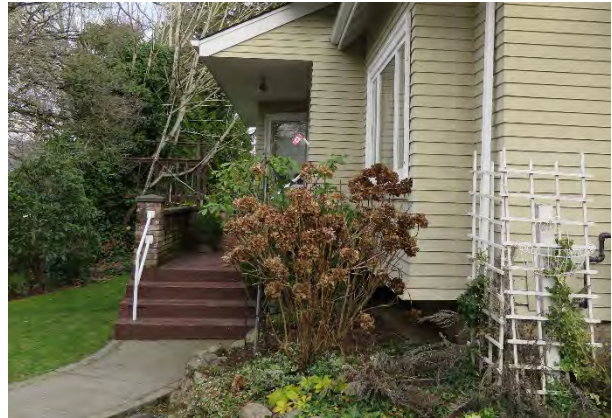
*Photo taken January 2021 by the author.*

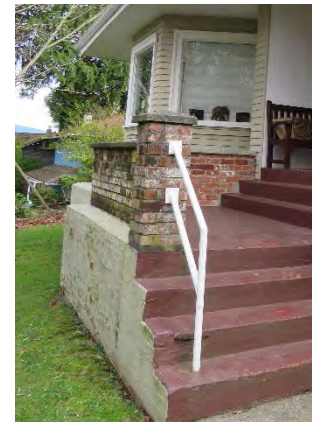
The roofing system is different as well. Unfortunately, there are no historic photographs that show all of the porch roof as it was, but it clearly had deep overhangs past the edge of the lower deck and was supported by square, likely cedar, posts. These posts were supported in turn by solid, square pedestals that look as though they were clad in stucco. Given that the current porch is concrete, and the original porch was constructed of wood, there is little left in terms of clues as to the size of the original porch. The above historic photograph gives an indication of the size and depth of the original porch and shows that the porch was wider (from west to east) than it is now, seemingly reaching to the far east edge of the house.

It is possible that the brick clad pedestal that is on the lower decking might have been re-used from the original porch, or even left in place, when the new porch was constructed. But this is mere speculation and was more likely new as part of the renovations. Without proof that it is an original component, there is no reason to retain and re-use it as part of this project.

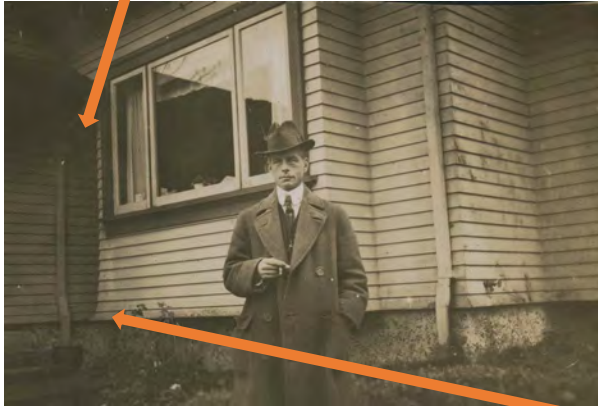
Bump-out was separate from the porch wall and then filled in later.

*RD Travers in front of 7828 Stanley Street, 1921.  
Photo courtesy of Heritage Burnaby, Item # 477-461.*

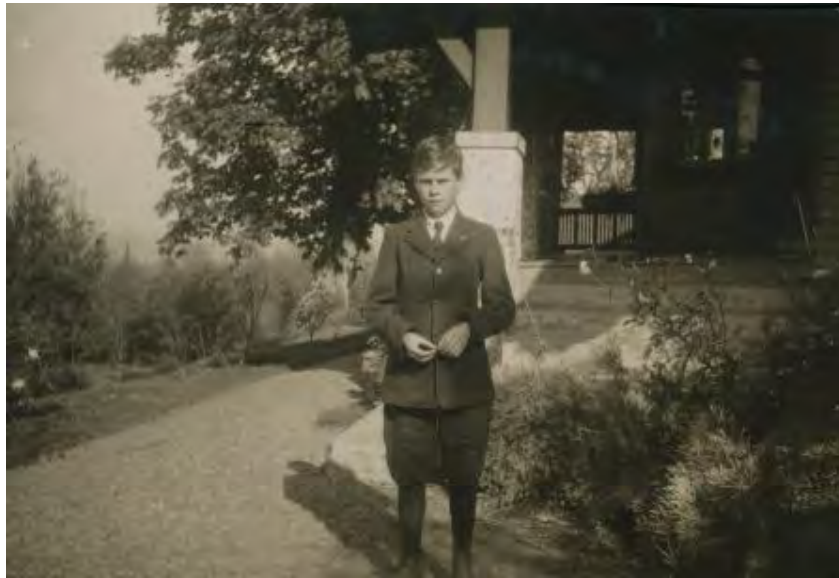
Below are two photographs from 1921, that show some of the porch:

*Robbie Travers in front of 7828 Stanley Street, 1921.  
Photo courtesy of Heritage Burnaby, Item # 477-464.*

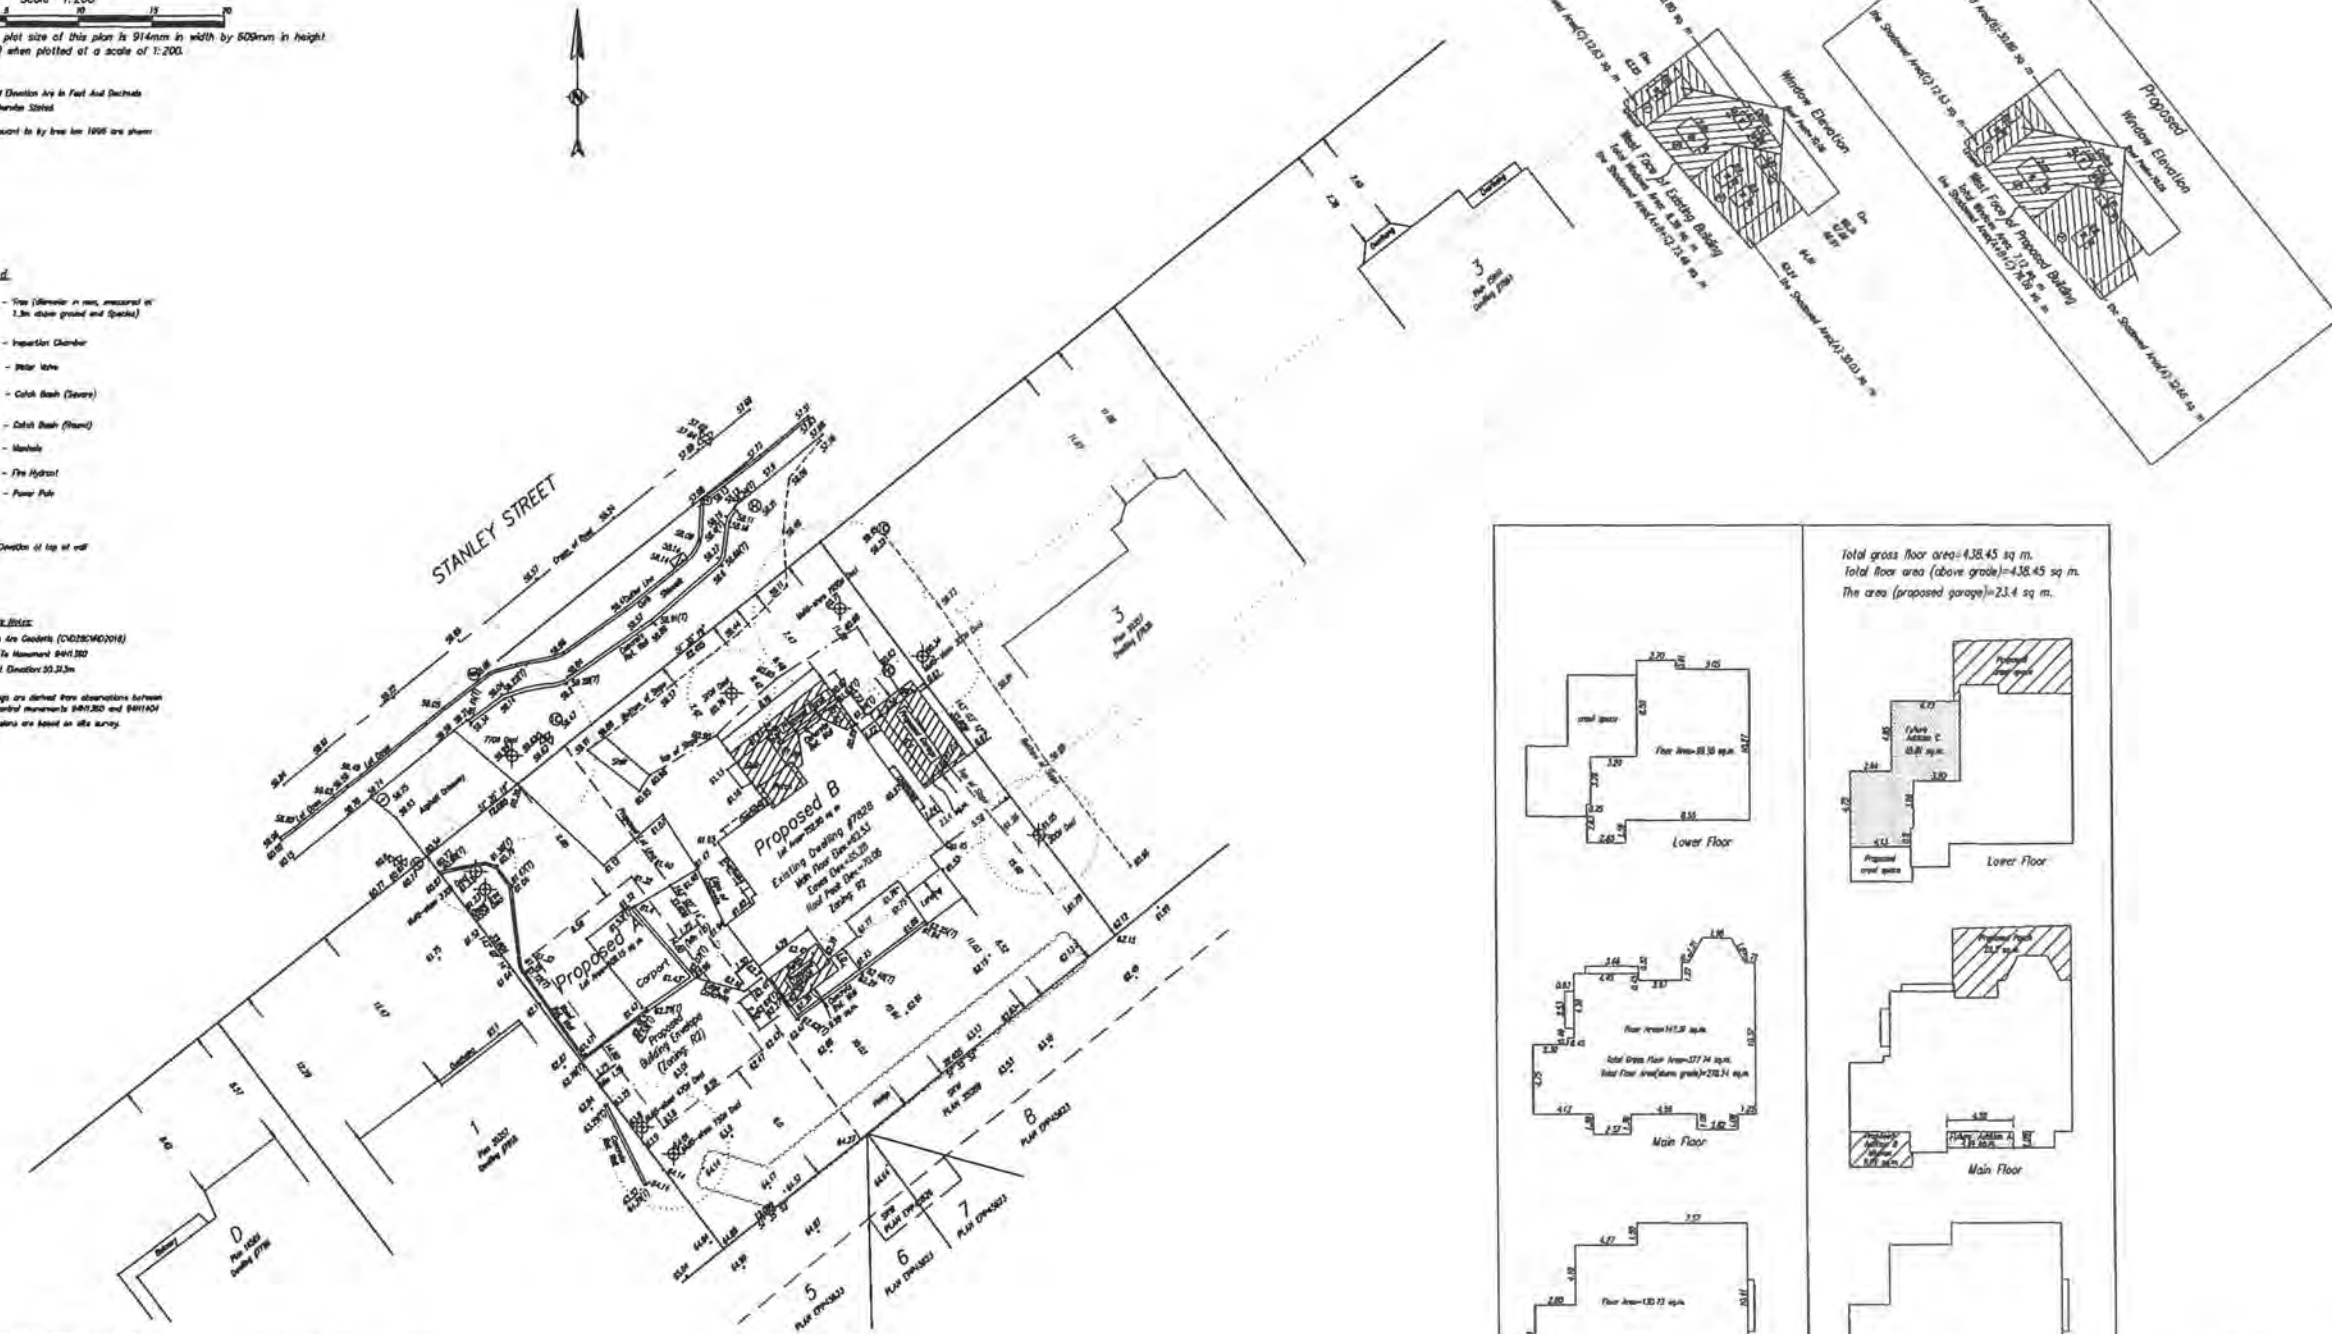
| Lot | Front | Address |
|---|---|---|
| 2 | 11.67 | 7838 |

Average = 10.30  
Proposed Setback Lot A = 8.8in
