CITY OF BURNABY BYLAW NO. 14574

A BYLAW to authorize a heritage revitalization agreement for Alice and Robert Travers Residence

ALICE AND ROBERT TRAVERS RESIDENCE (7828 STANLEY STREET)

Heritage Conservation Plan Arthur Long Residence 7828 Stanley Street Burnaby, BC

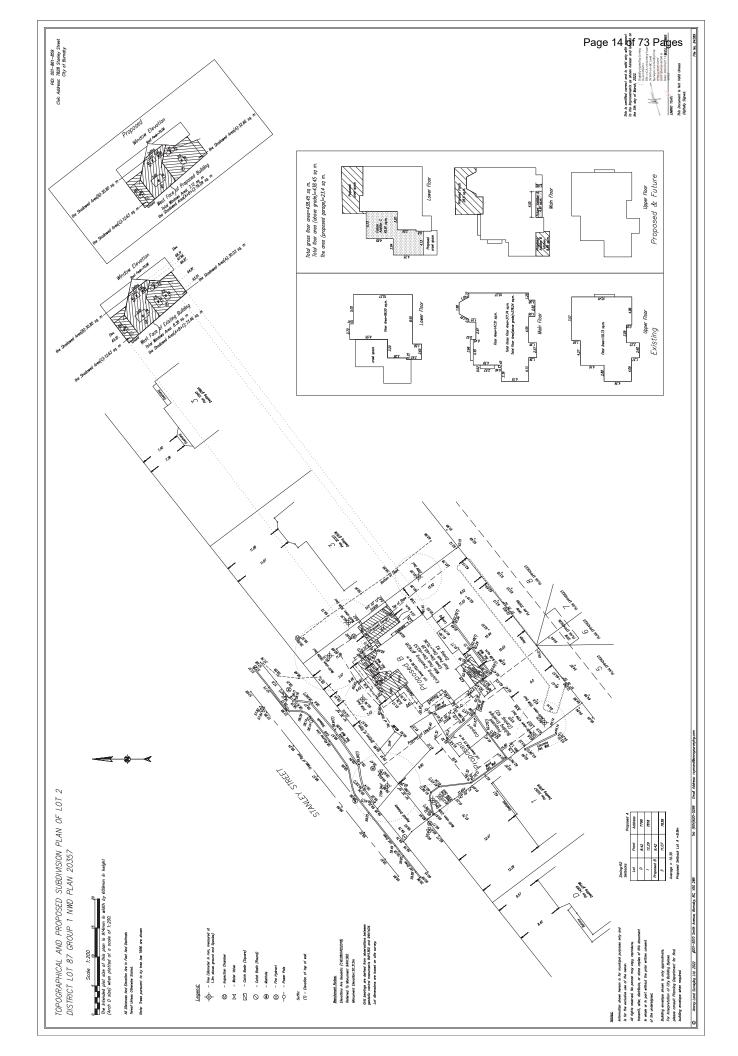
PROPOSED SUBDIVISION PLAN

- (a) a full height basement to replace the existing cellar, including those crawl spaces and that addition shown in those locations labelled "Proposed crawl space" and "Future Addition C" within the Lower Floor on the Proposed Subdivision Plan;

- (c) a single car garage as shown in that location labelled "Proposed Garage" on the Proposed Subdivision Plan.
- 3. The parties acknowledge that the Owner has applied for approval to subdivide the Lands and has received tentative approval, subject to the conditions set out in a letter from the Approving Officer to the Owner dated October 17, 2022 and any subsequent amendments.

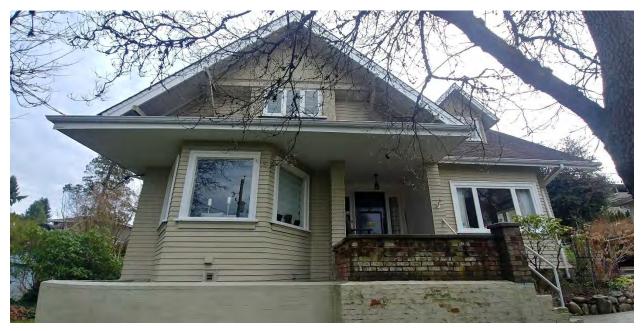
North (front) elevation

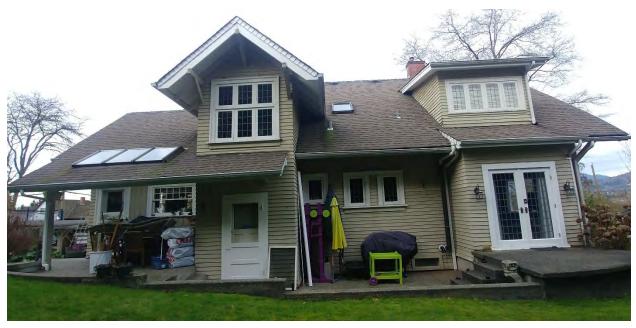
South (rear) elevation

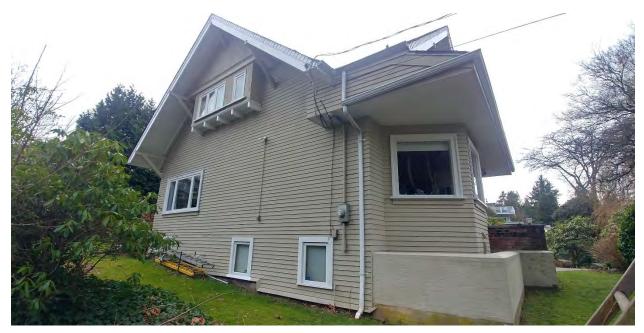
East elevation

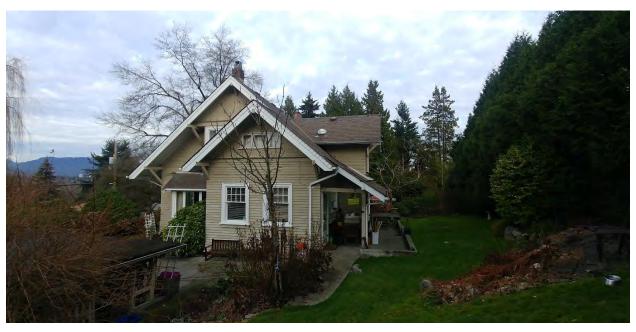
West elevation

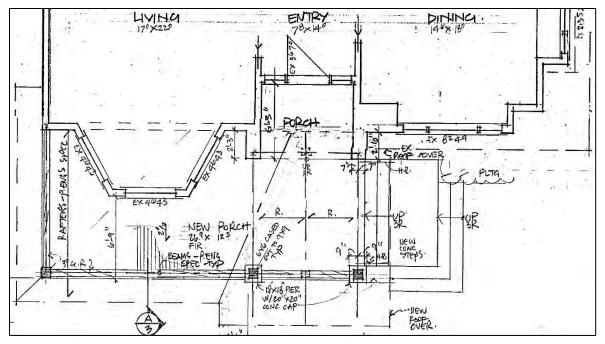
Portion of plan showing the proposed new porch, courtesy of Rob Johnson, Architect.

- 10) Reinstate the exterior form by recreating missing or revealing obscured parts to re-establish character-defining proportions and massing. The front porch will be reconstructed to as close as the original as possible, based on the evidence at hand.

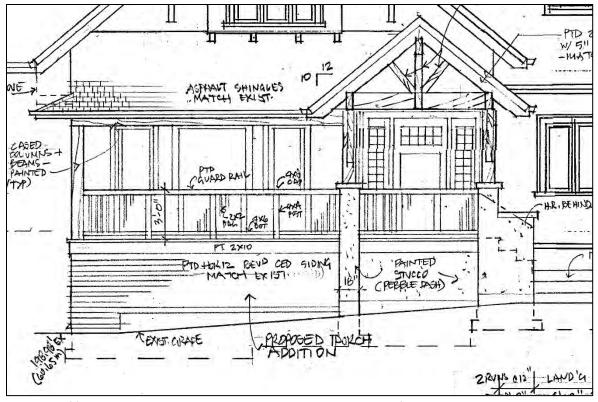
Portion of front elevation showing the proposed new porch, courtesy of Rob Johnson, Architect.

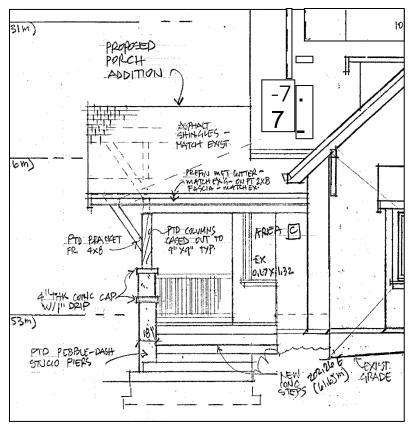
Portion of west side elevation showing the proposed new porch, courtesy of Rob Johnson, Architect.

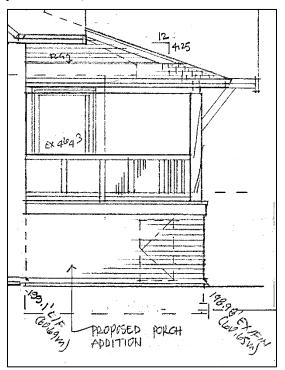
Portion of east side elevation showing the proposed new porch, courtesy of Rob Johnson, Architect.

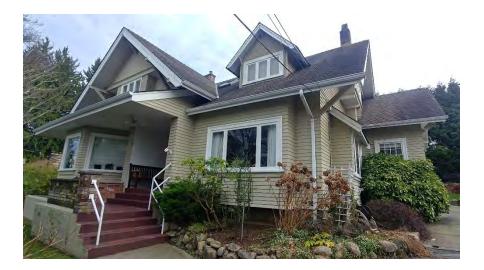
- a small, triple sash window in the dormer located on the western side of the front elevation

- a small, single window with a multi-pane upper sash on the large bump-out to the west side of the house

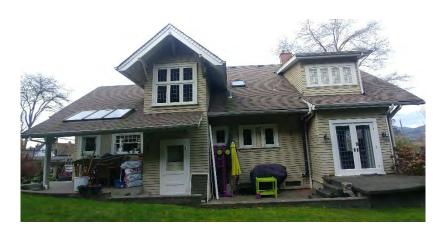
The rear elevation appears to have some newer windows as well as what might be original windows, and consist of the following:

- a single, horizontal window with a multi-paned upper sash on the main level of the west side
- a set of three, single, multi-paned casement windows in the middle of the main level of the elevation
- a large, triple, multi-pane window in the gable dormer
- a quad, multi-pane window in the shed dormer

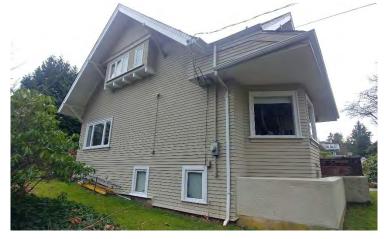
The east elevation has the following window types:

- three, small, square, single windows along ground level
- a medium-sized, triple sash window to the south side of the main level
- a medium-sized, triple sash window and a single window on the bump-out on the upper level

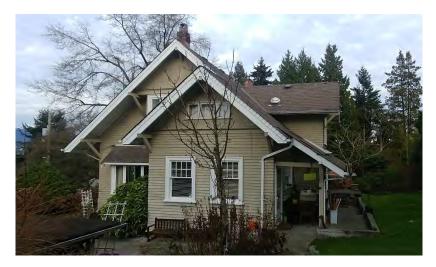
The west elevation has the following window types:

- a medium-sized, triple sash window in the shed bay at the front (north) side of the main level

- a medium-sized, double window beside a single window within the same casing on the bump-out on the upper level

- a small, triple window in the gable of the large bump-out

Ideally the location, size, and design of all the historic windows on the house would be retained as they are an important aspect of the heritage value of the house. Unfortunately, due to the requirements noted by the Approving Officer, the setback for the side yard on the west side of the house must be a minimum of 1.5 metres. This has resulted in the percentage of unprotected openings on that elevation being over the allowable as per the BC Building Code, thus necessitating the removal of one or possibly both of the historic windows on the main floor level. Although unfortunate, it is a reasonable solution to a difficult situation.

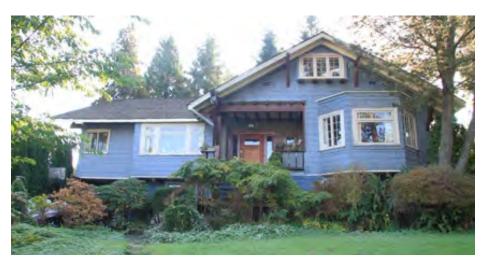
Photograph of 7864 Stanley Street, courtesy of the Heritage Burnaby Website, date unknown.

The fact that the subject house and the Ramsay house are almost next door to each other adds to the heritage value of both houses, as it is easy for passers-by to appreciate the two similar designs by this great architect. Some of the similarities between the two neighbouring houses include the dominant cross-gable roof, the triangular eave brackets, the bump-outs, the three-sided bay on the front elevation, and the front door with side-lites.

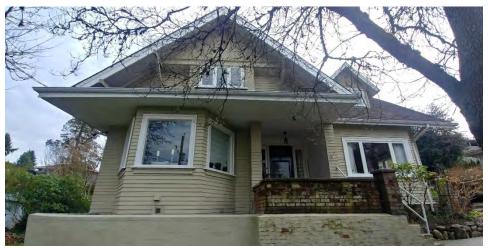
Photograph of 7828 Stanley Street by the author.

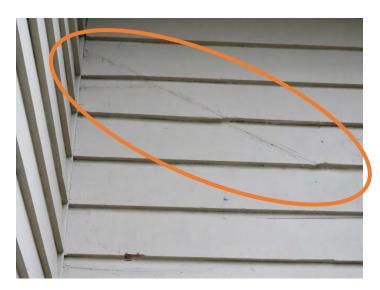
The photograph below is a close-up of the area shown in the photograph above on the right, specifically of the area at which the orange arrow is pointing. It shows the marks of something that has been removed. As this wall would have been new when the bump-out was widened, it is unclear what was here between then and now, perhaps a different roof system?

Bump-out was separate from the porch wall and then filled in later.

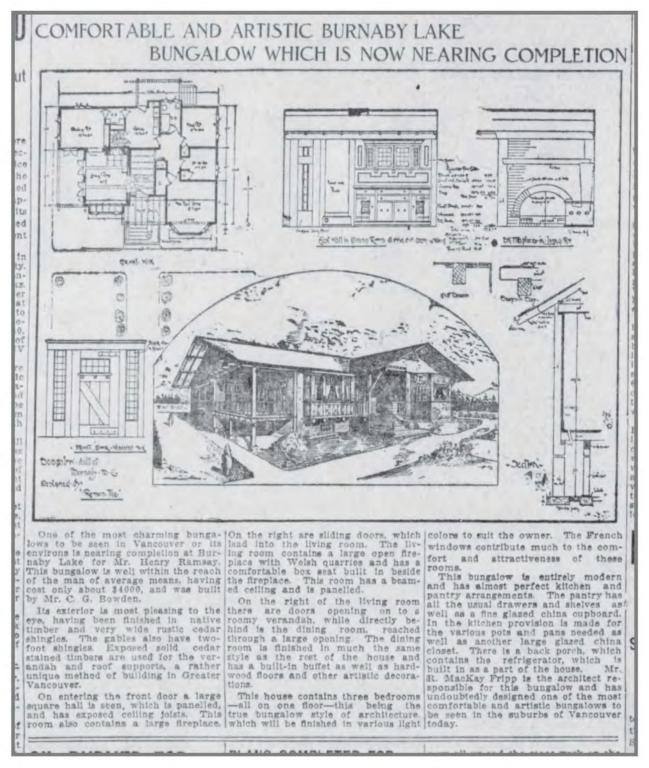
Plans of the Henry Ramsay Residence, 7864 Stanley Street, Burnaby, BC The Province, June 8, 1912, p. 28. Courtesy of Jim Wolf

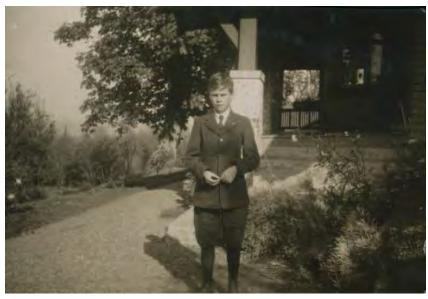
Robbie Travers in front of 7828 Stanley Street, 1921. Photo courtesy of Heritage Burnaby, Item # 477-464.

The existing front porch is not the original. At some point in the past, the original porch was removed and replaced with concrete steps and decking. The roof over the porch was also changed at some point. According to historic photographs, the original roof had deep-set eaves and was supported on square wooden posts.

Below are two photographs from 1921, that show some of the porch:

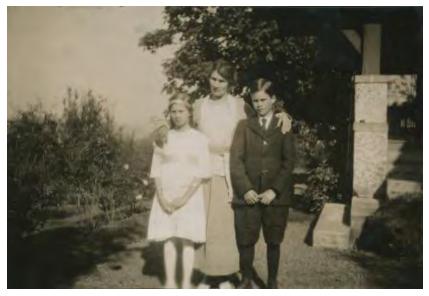
Alice Travers with children Robbie and Maude in front of 7828 Stanley Street, 1921. Photo courtesy of Heritage Burnaby, Item # 477-460.
