TRAFFIC SAFETY COMMITTEE

SUBJECT: LEFT TURN BAY ON CAMERON STREET AT BEAVERBROOK DRIVE

SUBJECT: LEFT TURN BAY ON CAMERON ST AT BEAVERBROOK DR

PURPOSE: To review a request for a left turn bay on Cameron St at Beaverbrook Dr.

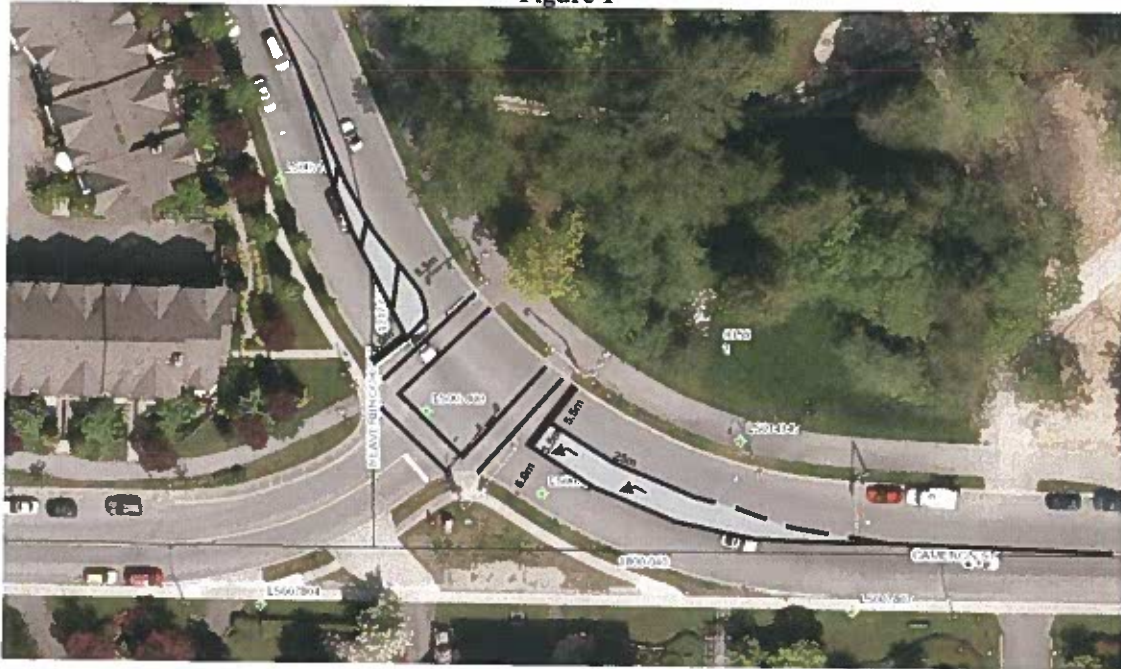
Figure 1

The intersection of Cameron and Beaverbrook is a signalized intersection composed of three legs as shown on *Figure 1*. The south eastern leg is the portion of Cameron St that is designated as a major collector. The northerly leg is Beaverbrook Dr (also designated as a major collector) which connects directly to the south eastern leg of Cameron St. The western leg is the portion of Cameron St that is designated as a local street. The local street tees into the major collector route of Cameron-Beaverbrook.

Given the benefits of a painted left turn bay and no significant negative implications as noted above, it is recommended that a painted left turn bay for westbound traffic be installed at the intersection of Cameron and Beaverbrook. The proposed left turn bay is shown in Figure 1. If approved, the installation will be scheduled for Spring 2012 when weather conditions are better. Funding for the work is available from the 2012 operating budget.

A painted left turn bay accommodating approximately 4 vehicles can be installed without any road widening, signal modifications or impact to through vehicle movements. Approximately one existing parking space would need to be removed from the west side of Beaverbrook Dr.
