**SUBJECT:** **CANADIAN PACIFIC TRAIN DERAILMENT – METALLURGICAL COAL RECOVERY PLAN FOR SILVER CREEK, BURNABY LAKE AND BRUNETTE RIVER**

**PURPOSE:** To inform Council on Canadian National Rail’s Metallurgical Coal Recovery Plan for Silver Creek, Burnaby Lake and Brunette River.

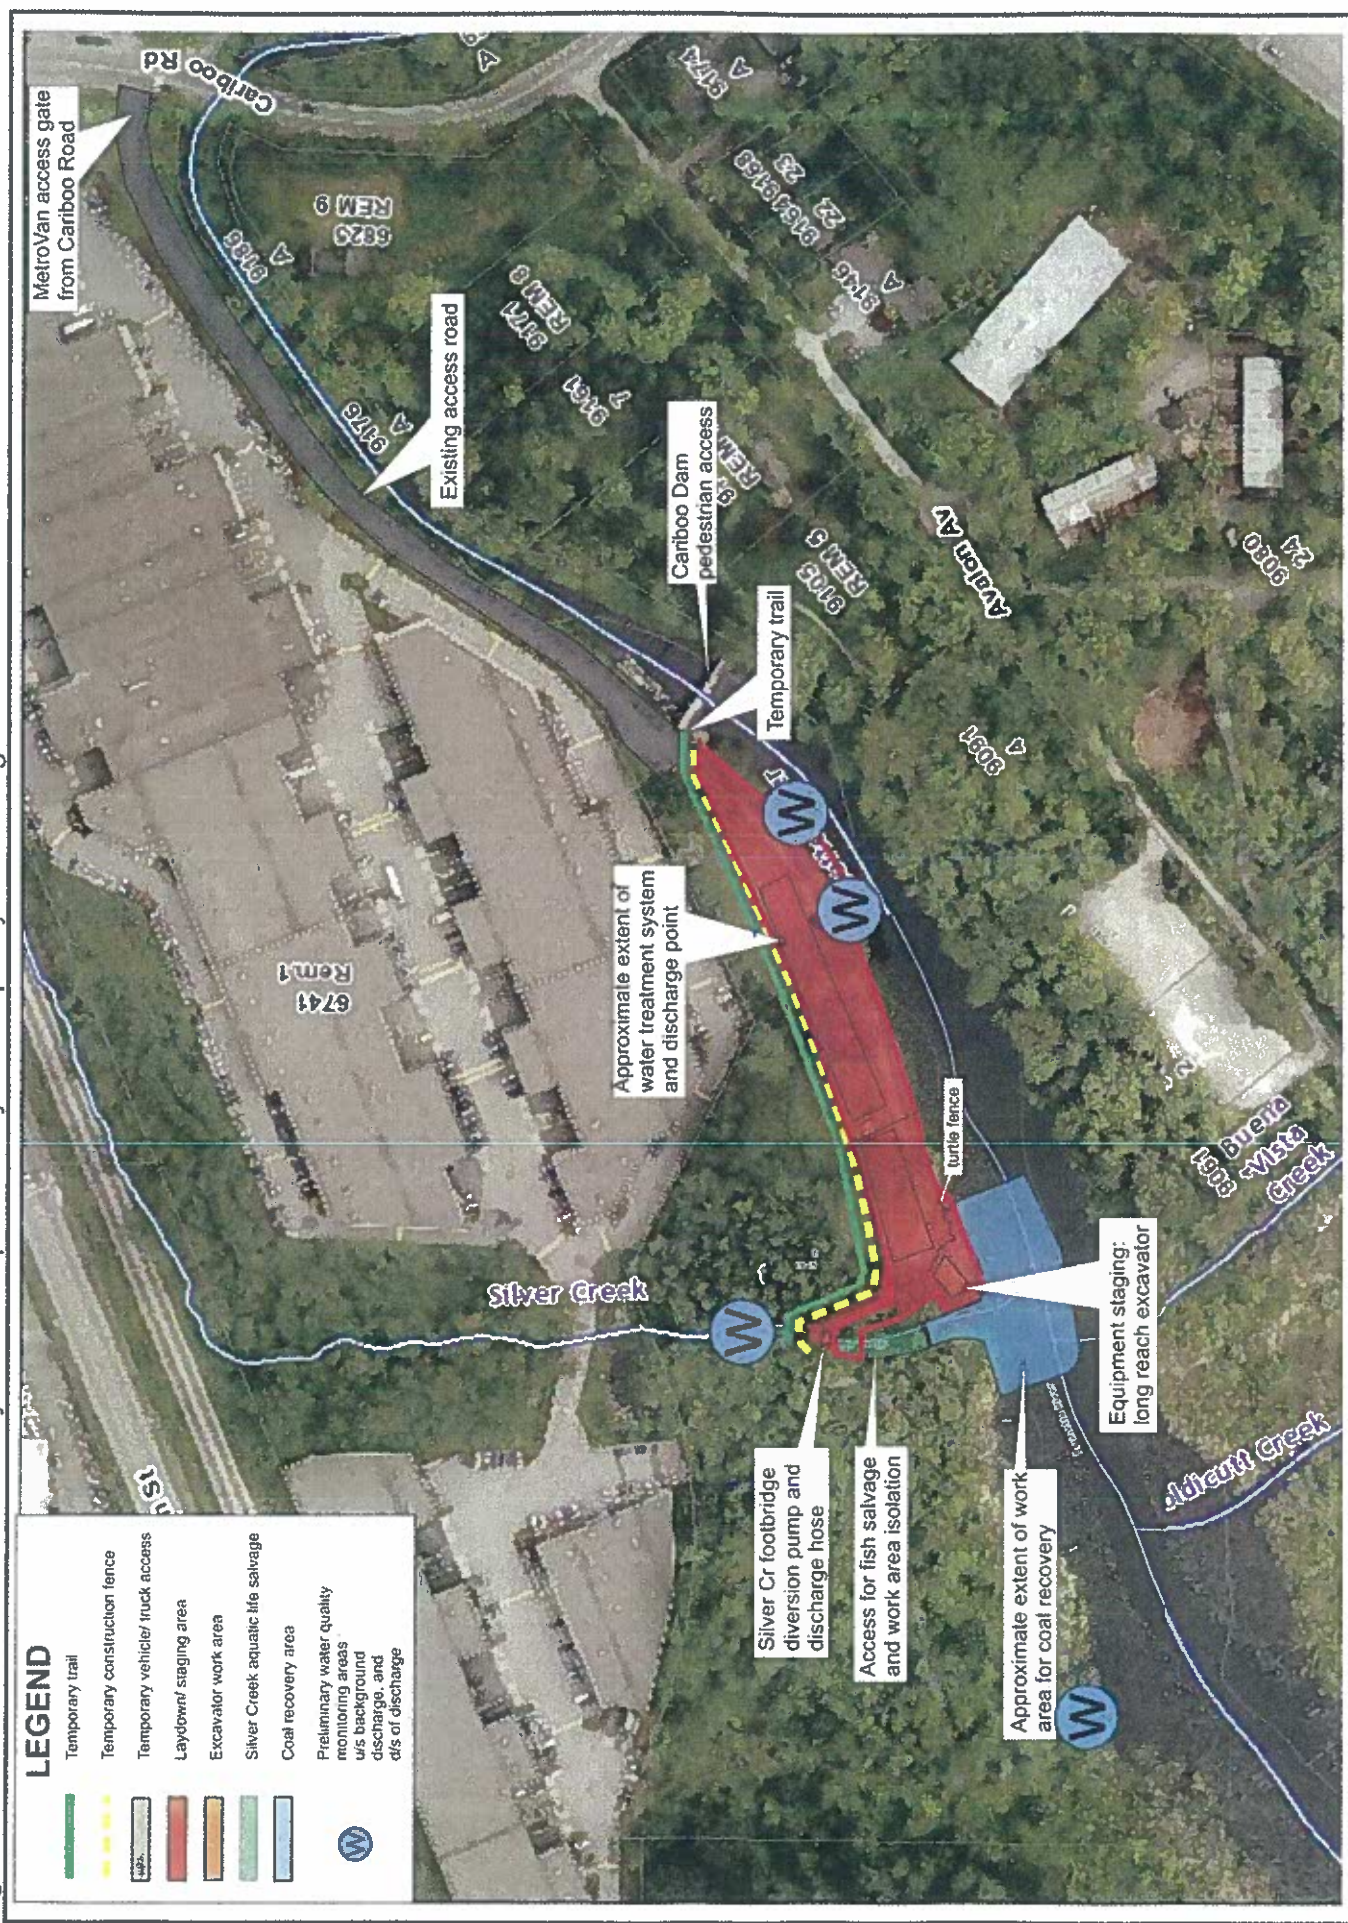
ATTACHMENT #1

Figure 4-1 Overview of coal recovery area and preliminary water quality monitoring stations

Site access, water treatment plant location, equipment staging area and water quality monitoring are noted in *Attachment #1*. CN has received authorization from Metro Vancouver to temporarily locate the multi-staged water treatment plant in the regional park and to temporarily relocate the public access path around the work area.
