SUBJECT: SAFETY COUNTERMEASURES – CANADA WAY AT RAYSIDE STREET

PURPOSE: To review road safety concerns along Canada Way at Rayside Street.

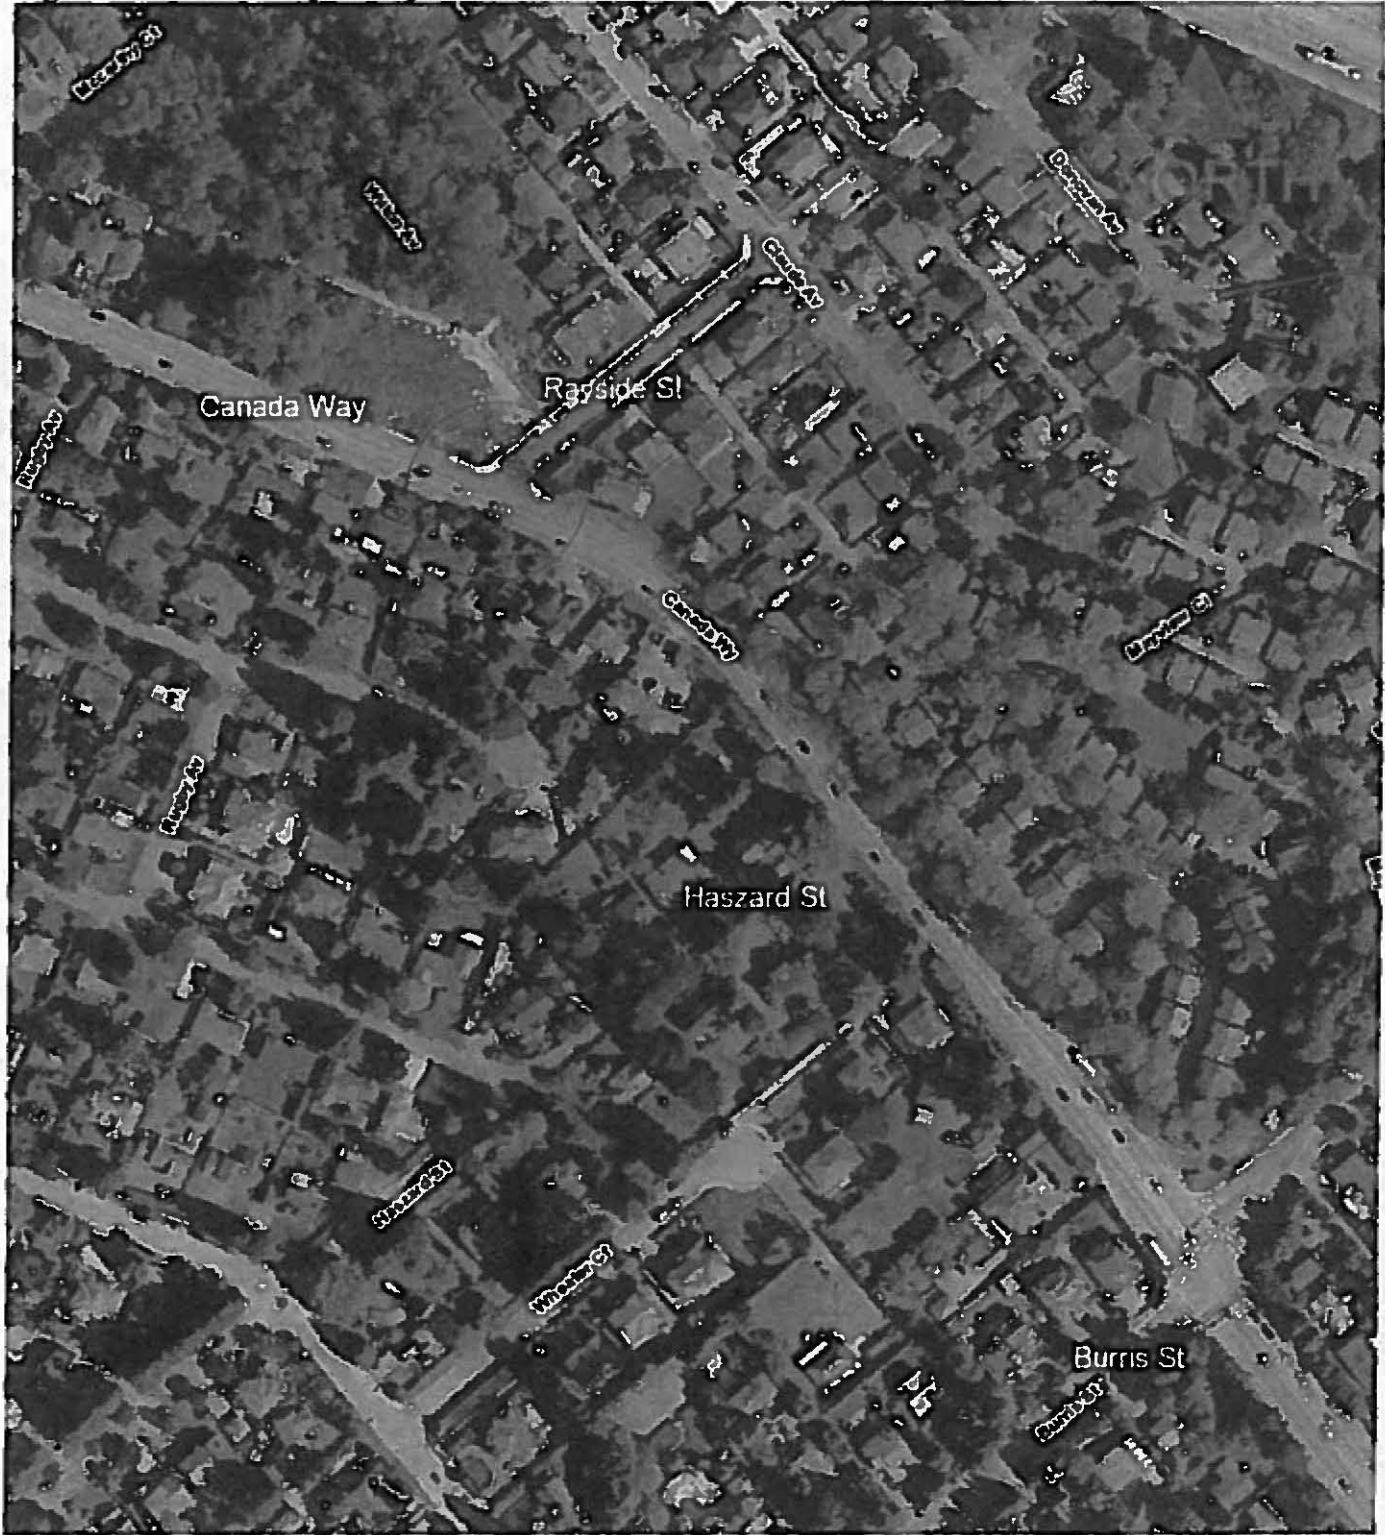
Figure 1: Canada Way at Rayside St

Canada Way is classified as an arterial road as well as a truck route, and is one of the key east-west streets across the City. Figure 1 show the 5400-5600 block of Canada Way which includes the Canada Way/Rayside St intersection. Just east of the Rayside St intersection is where there is a horizontal bend along Canada Way of about 26 degrees, as well as a relatively steep grade of about 9 degrees. The road design meets standards for the posted speed limit of 50 km/h, but drivers travelling at excessively high speed have encountered difficulties in controlling their vehicle.

- a) Install a curve warning ahead sign for westbound motorists;
- b) Install a new and improved speed reader board. A new one is recommended to reduce maintenance cost, allow easier data collection, and provide multiple options for driver feedback features such as a flashing white light;

- c) Install reflective delineator posts along the centre line of Canada Way and raised pavement markers along the white dashed lines for the length of the curve to further highlight the curvature of the road and prevent excessive speeds. The delineator posts would also help to reinforce the restricted access to Rayside St.

- d) Install reflective markers along the face of the existing barriers along the north side of the road for improved visibility at night;
- e) Reinstall barriers at the northwest corner of the intersection to protect against a crash with the Hydro pole at that location;

- f) Install a breakaway support system at the base of two existing street light poles on the north side of Canada Way to help reduce injuries should a crash with those poles occur;
